POOL FAILURE ISSUES

POOL REPAIR / REPLACEMENT

CITY OF LOS ANGELES
DEPARTMENT OF REC. & PARKS
200 N. MAIN STREET, RM. 1250
LOS ANGELES, CA 90012

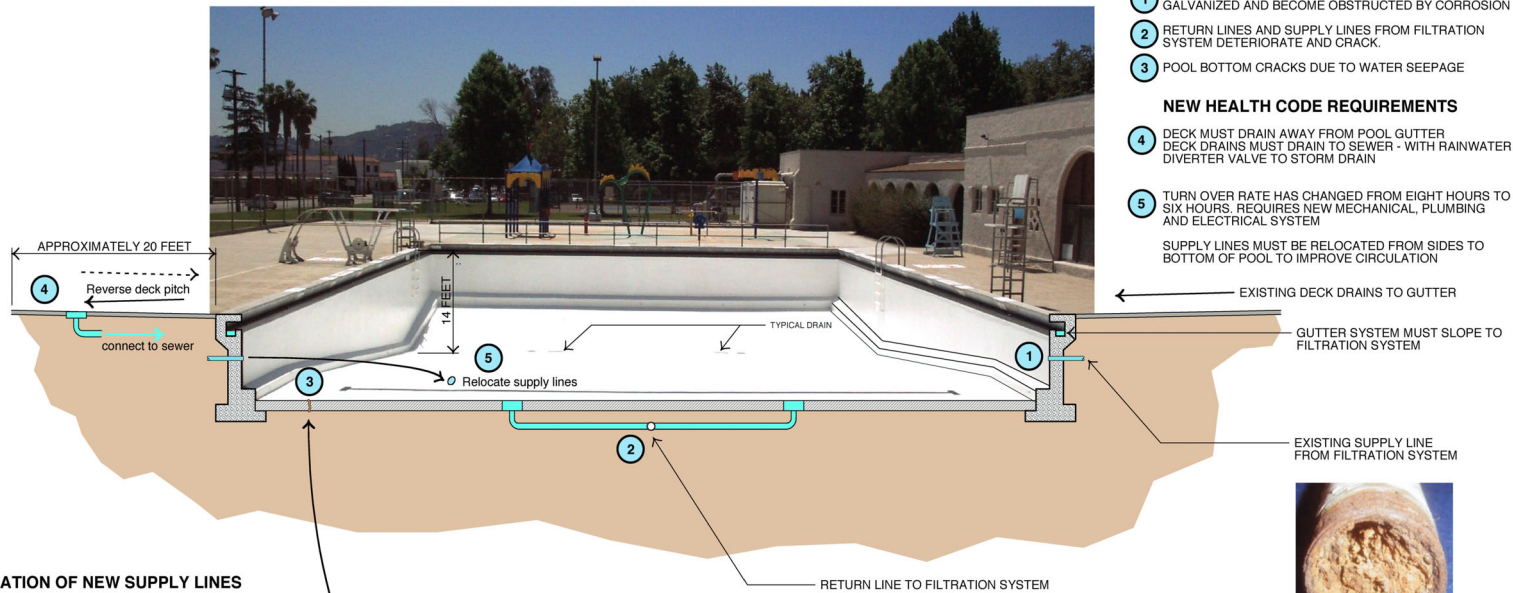
TYPICAL POOL CROSS-SECTION

- ① SUPPLY LINES FROM FILTRATION SYSTEM ARE USUALLY GALVANIZED AND BECOME OBSTRUCTED BY CORROSION
- ② RETURN LINES AND SUPPLY LINES FROM FILTRATION SYSTEM DETERIORATE AND CRACK.
- ③ POOL BOTTOM CRACKS DUE TO WATER SEEPAGE

- ④ DECK MUST DRAIN AWAY FROM POOL GUTTER DECK DRAINS MUST DRAIN TO SEWER - WITH RAINWATER DIVERTER VALVE TO STORM DRAIN
- ⑤ TURN OVER RATE HAS CHANGED FROM EIGHT HOURS TO SIX HOURS. REQUIRES NEW MECHANICAL, PLUMBING AND ELECTRICAL SYSTEM

SUPPLY LINES MUST BE RELOCATED FROM SIDES TO BOTTOM OF POOL TO IMPROVE CIRCULATION

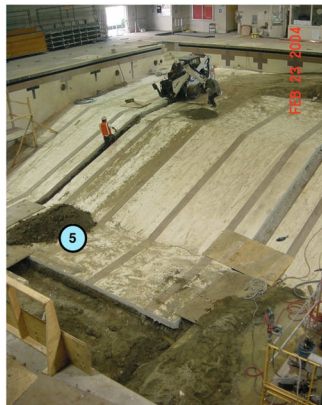
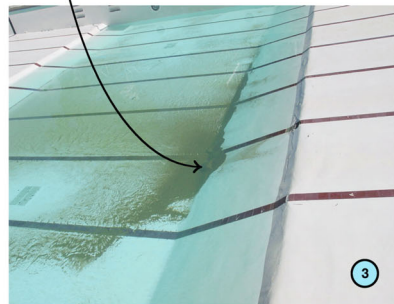
INSTALLATION OF NEW SUPPLY LINES

PROBLEM:
CRACKS IN SUPPLY OR RETURN WATER SYSTEM UNDERMINES POOL BOTTOM AND CREATES CRACKS.

CONSEQUENCES:
SEDIMENT LEACHES INTO POOL. HYDROSTATIC PRESSURE CAUSES UPLIFTING OF POOL. GUTTERS NO LONGER DRAIN PROPERLY.

PROBLEM:
DETERIORATED & CRACKED SUPPLY OR RETURN LINES LEAK WATER.

CONSEQUENCES:
WATER UNDER POOL CREATES HYDROSTATIC PRESSURE WHICH UNDERMINES FOUNDATION AND SYSTEMS

PROBLEM:
GALVANIZED IRON WATER SUPPLY PIPES ARE CORRODED

CONSEQUENCES:
INADEQUATE TURNOVER OF FILTERED WATER RESULTS IN MURKY WATER
