STANWYCK RESIDENCE/OAKRIDGE ESTATE HISTORIC STRUCTURE REPORT

Prepared for
City of Los Angeles
Department of Recreation and Parks

Prepared by
Chattel Architecture, Planning & Preservation, Inc.
Los Angeles | San Francisco

April 2012

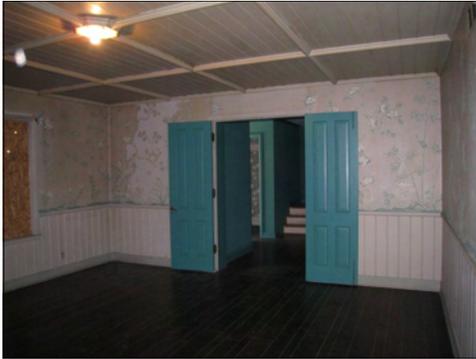
Dining room, view east, note damaged wall paper at northeast corner and missing

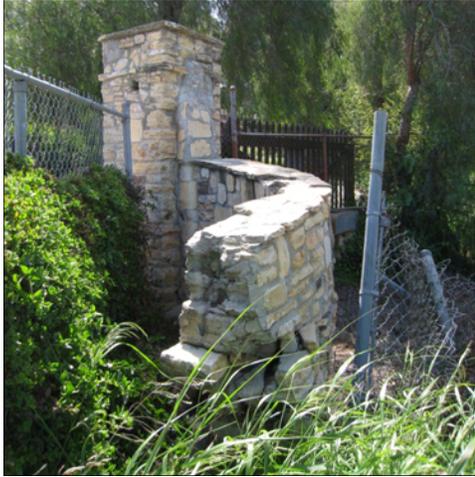
Main entryway gate east pillar, note structural damage and adjacent chain link fence (Chattel, 2011)

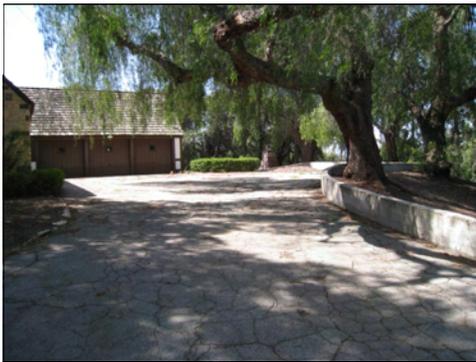
Cracks in driveway to garage wing, view south (Chattel, 2011)

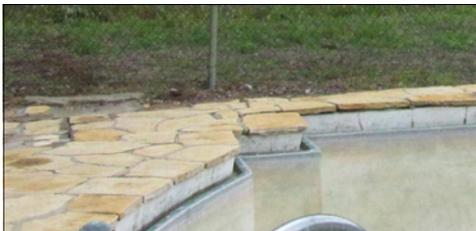
Some elements of flagstone paving are loose or missing (Chattel, 2011)

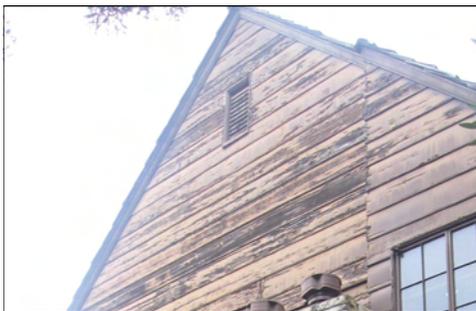
Dry rot on wood siding at central block east gable end (Chattel, 2011)

Wood on the residence's exterior, including false half-timbering at the south and side elevations; siding at gable ends; and piers at the rear porch (Space 26), exhibits dry-rot (Figure 92). Sources of moisture causing dry-rot that are evident should be addressed. For example, additional water damage to wood piers at the rear porch related to direct contact between these piers and the porch

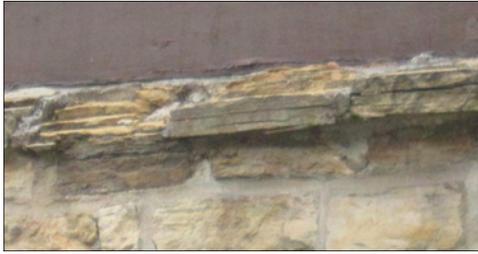
The residence exterior is generally in good condition. Areas of concern mainly include exposed wood, which shows signs of dry rot and moisture penetration. While most limestone veneer is in good condition, specific areas show signs of erosion. Significance, integrity, and condition of residence exterior character-defining features in need of repair or replacement are noted in Table 3.

Limestone veneer eroding at central block west elevation (Chattel, 2011)

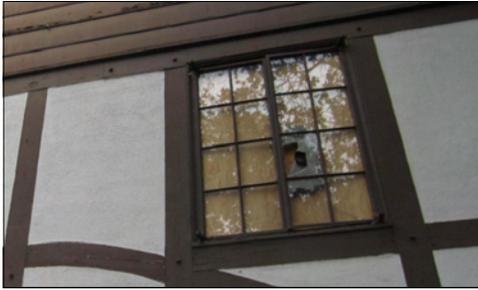
Broken window at central block west elevation (Chattel, 2011)

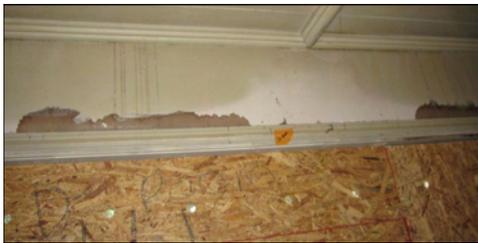
Damaged wall paper above window at dining room north wall (Chattel, 2011)

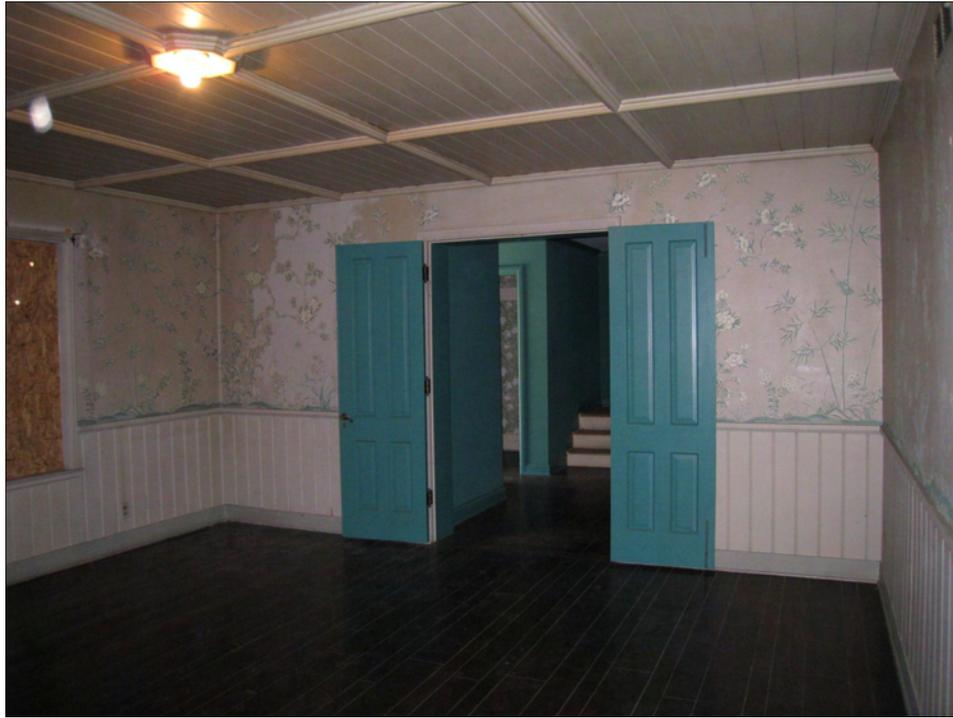
43: Dining room, view east, note damaged wall paper at northeast corner and missing chandelier (Chattel, 2011)

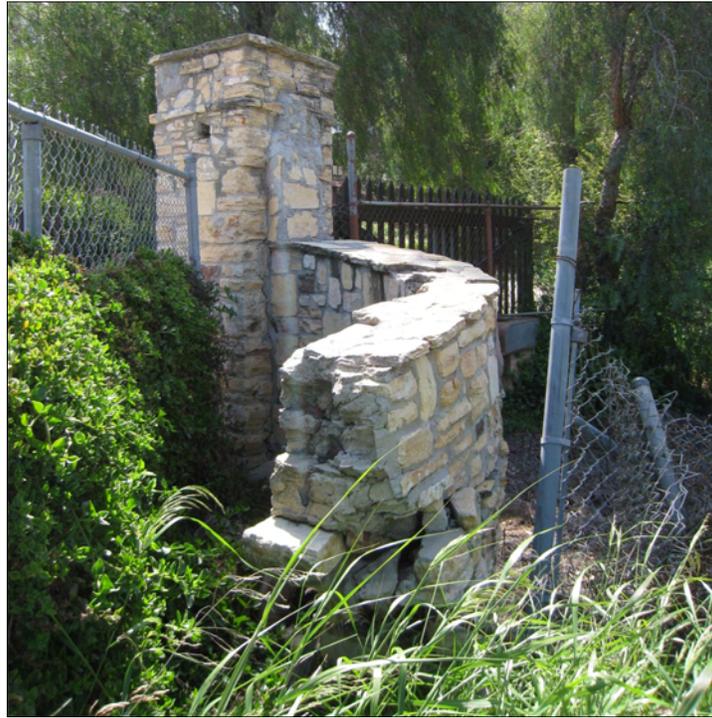
87: Main entryway gate east pillar, note structural damage and adjacent chain link fence (Chattel, 2011)

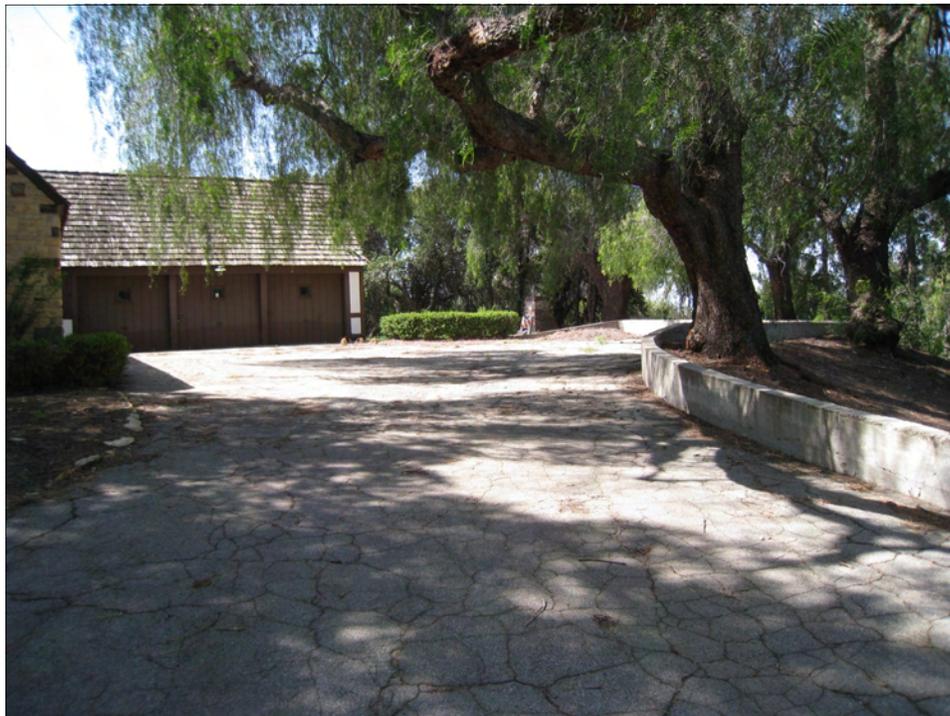
90: Cracks in driveway to garage wing, view south (Chattel, 2011)

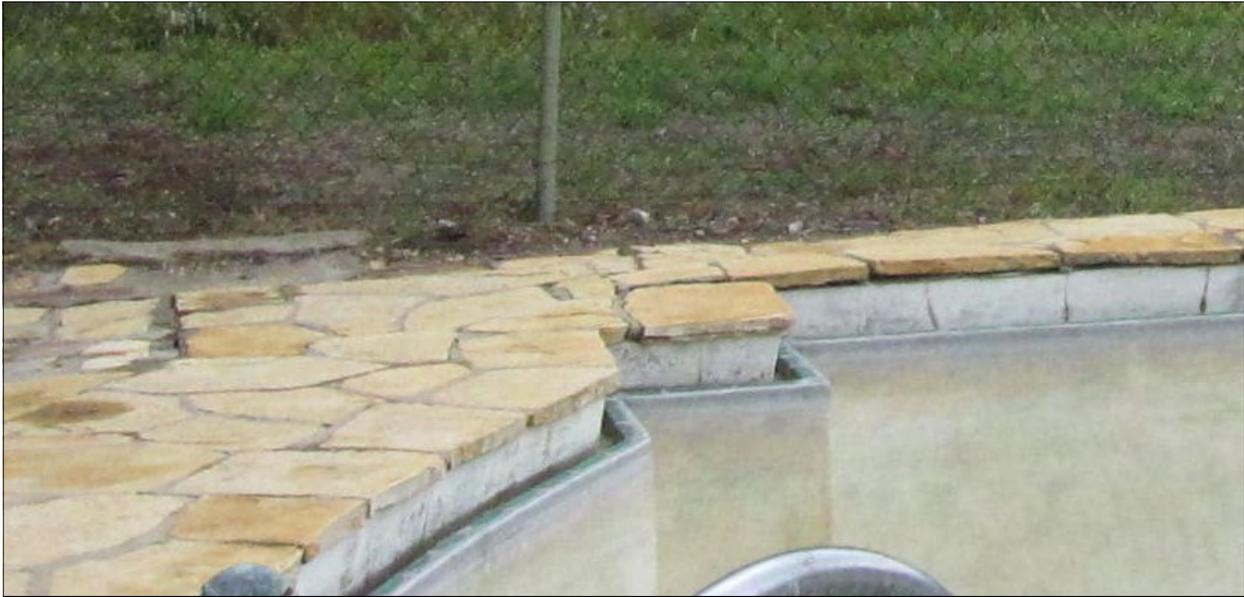
91: Some elements of flagstone paving are loose or missing (Chattel, 2011)

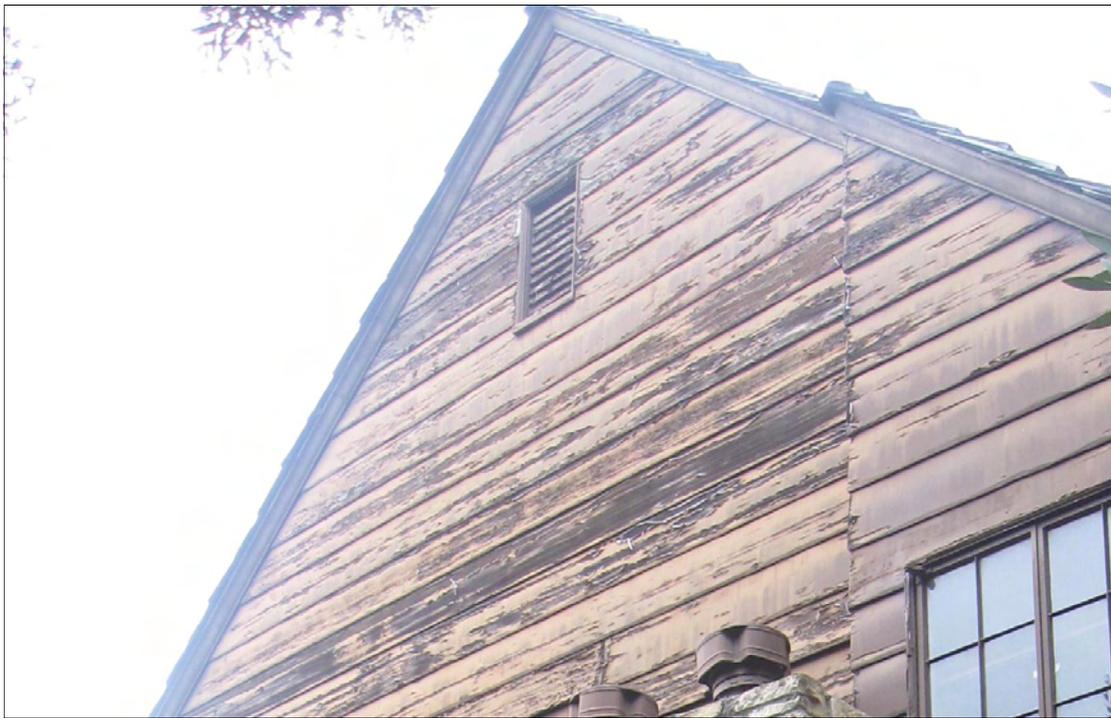
92: Dry rot on wood siding at central block east gable end (Chattel, 2011)

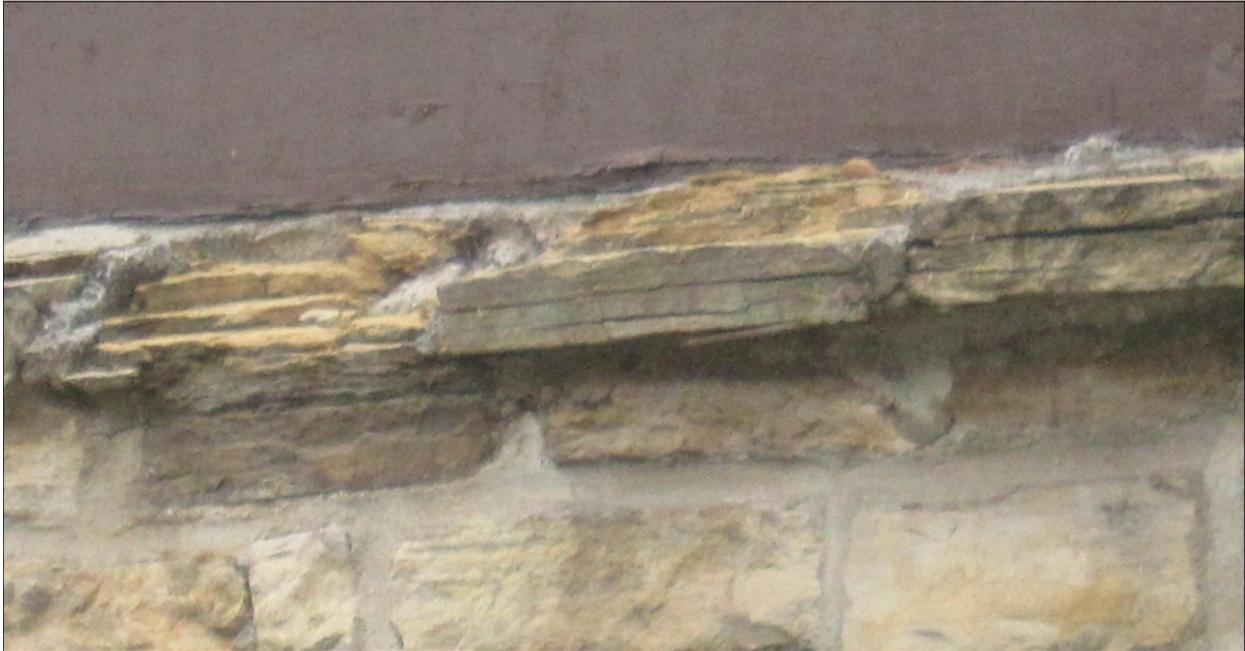
93: Limestone veneer eroding at central block west elevation (Chattel, 2011)

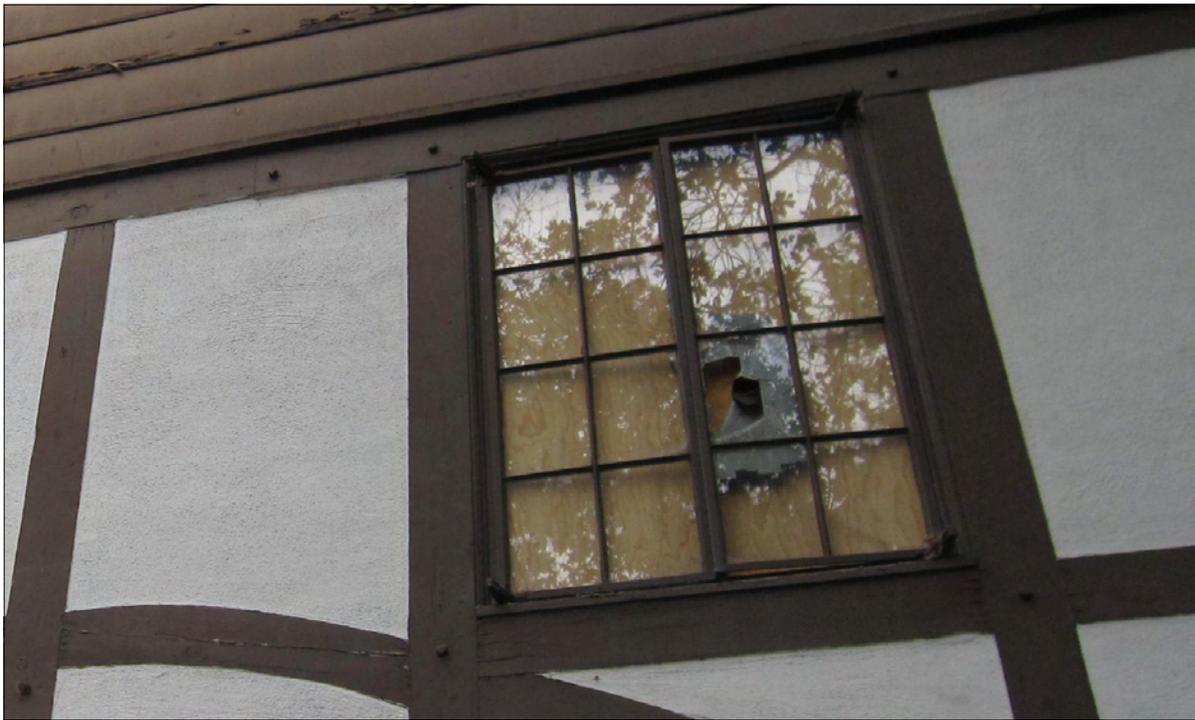
94: Broken window at central block west elevation (Chattel, 2011)

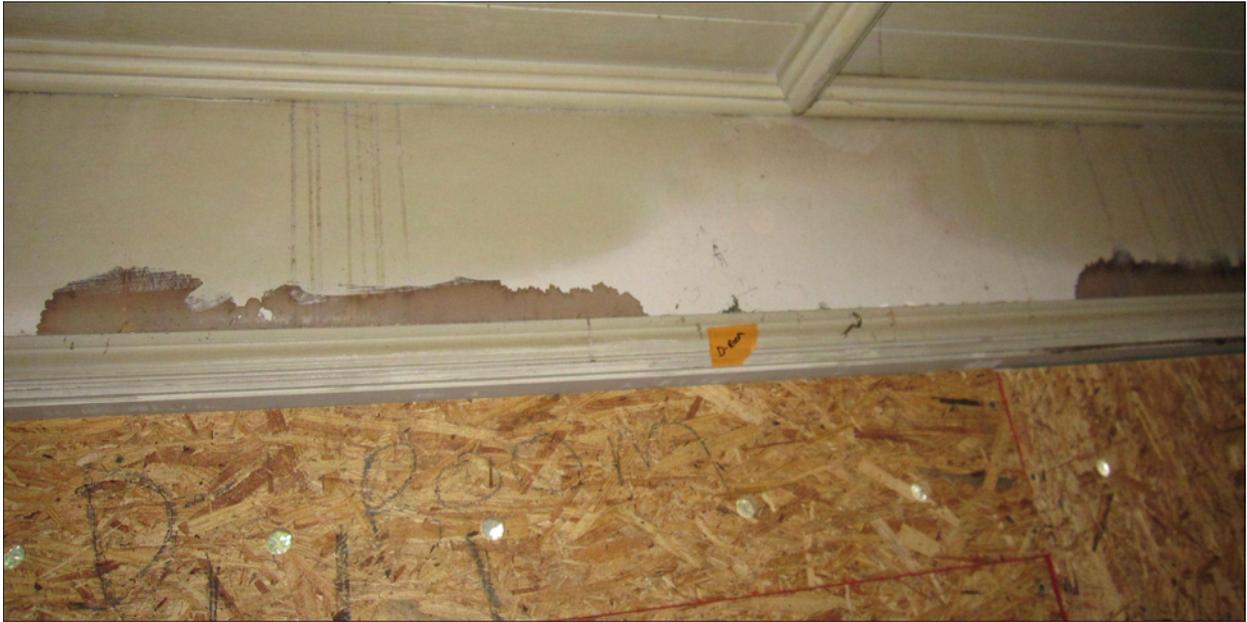
95: Damaged wall paper above window at dining room north wall (Chattel, 2011)
