Subject:
Asbestos-Containing Material Abatement
Oversight and Air Monitoring Services
Encino Balboa Golf – Restaurant
16821 Burbank Boulevard
Encino, California 91436

Date:
March 8, 2021

Our ref:
30081758

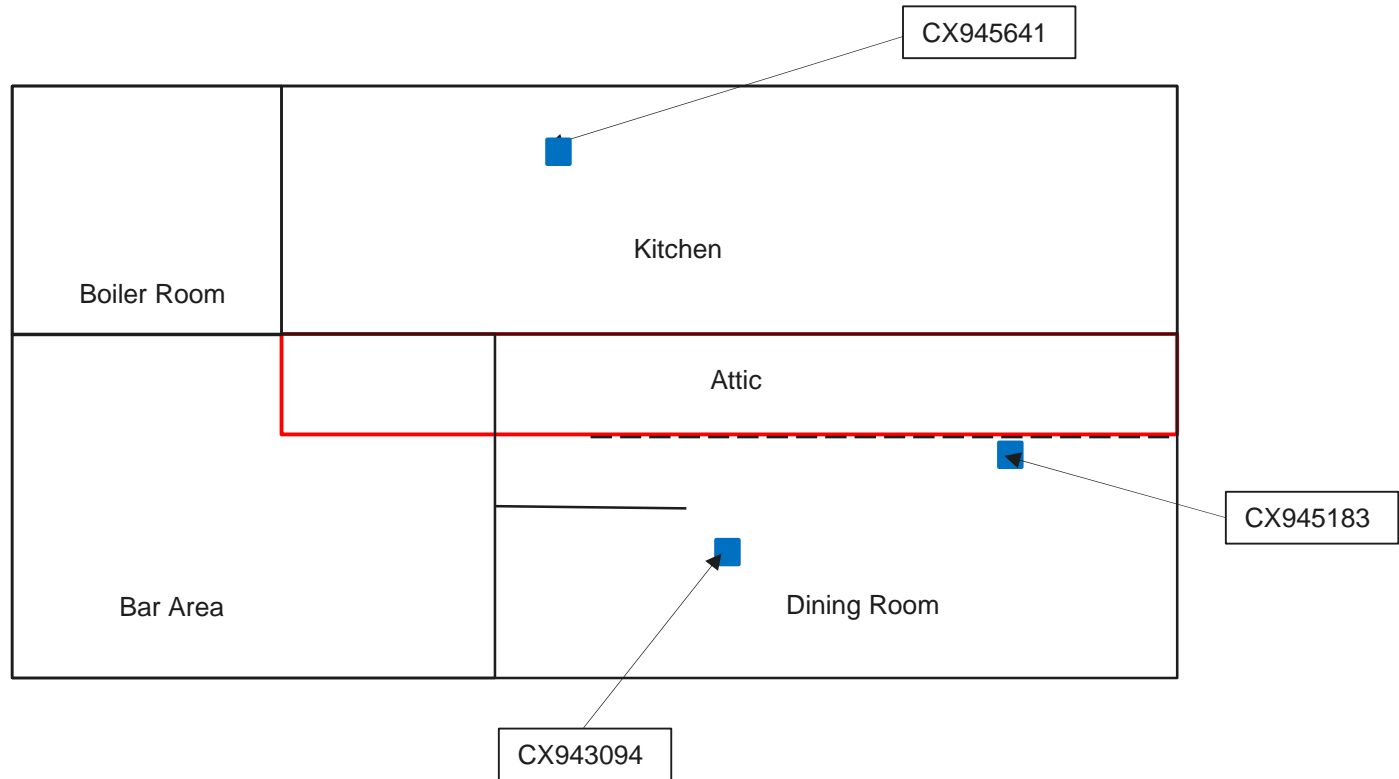
Asbestos Air Sample Locations Figure

Perimeter Asbestos Air Samples

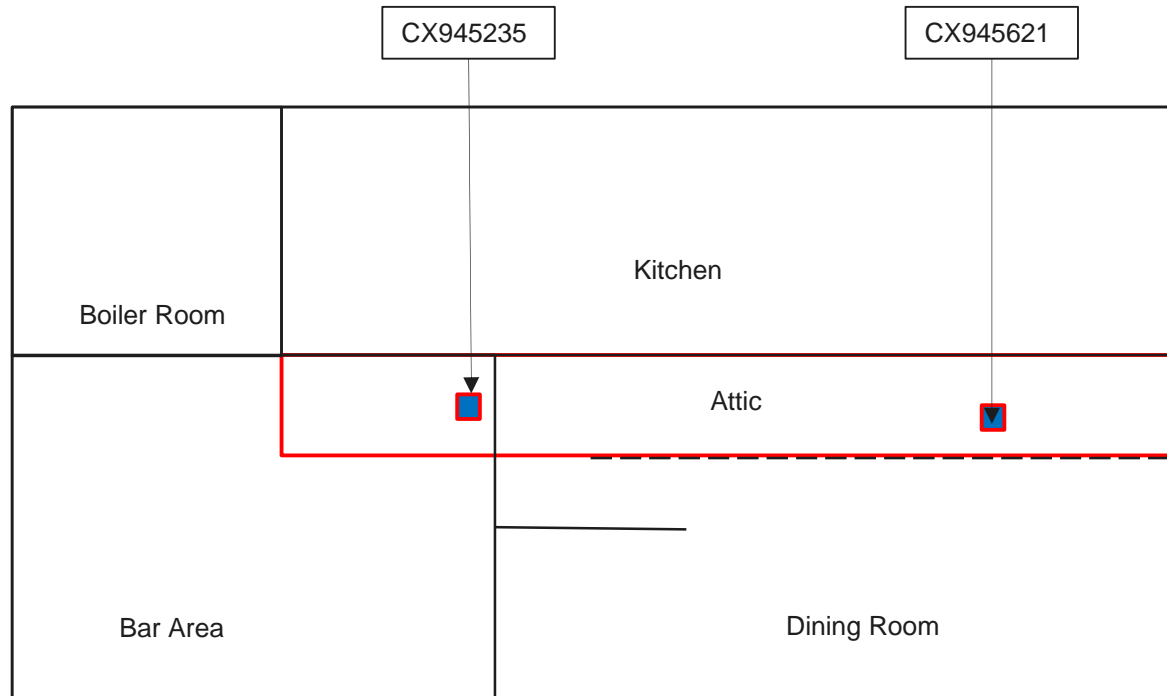
Asbestos Air Sample Locations Figure

0940 – Clearances have been achieved, both air samples below 0.01 f/cc. Arcadis notifies Resource of results. Resource will be leaving containment intact in the bar area (below the attic) to use for dust control during build-back.					
1000 – Arcadis leaves site.					
----- END OF REPORT -----					
Signature:

Clearance Asbestos Air Samples
