Subject:
Pre-Renovation Asbestos and Lead Survey
Encino Balboa Golf – Restaurant
16821 Burbank Boulevard
Encino, California 91436

Date:
January 19, 2021

This report focuses on suspect asbestos and lead building materials contained within the Restaurant within the Encino Balboa Golf property.

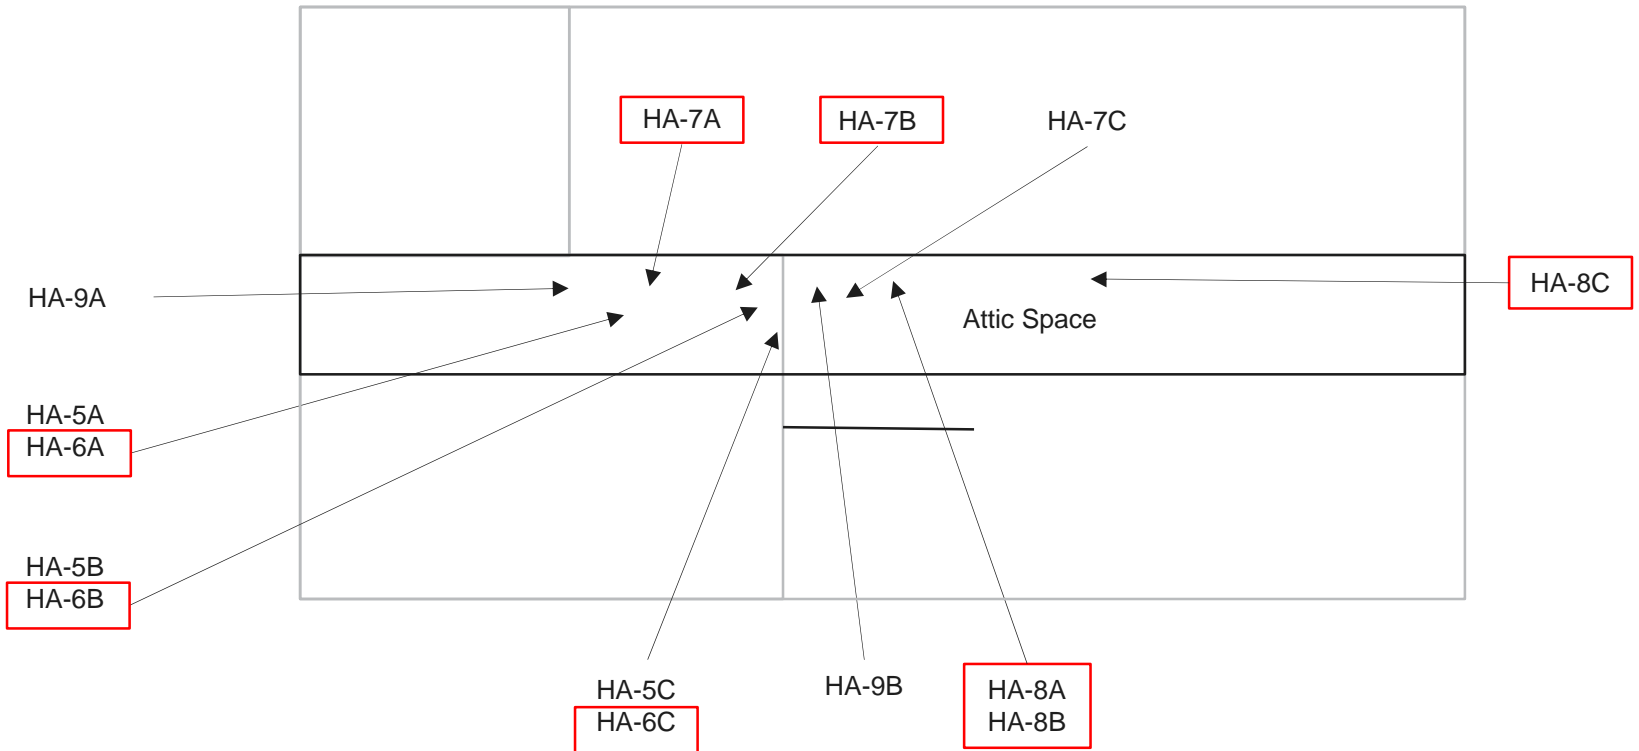
Asbestos Sample Locations Figure

City of Los Angeles Department of Recreations and Parks
Encino Balboa Golf Restaurant – Attic Space
16821 Burbank Boulevard, Encino, CA 91436

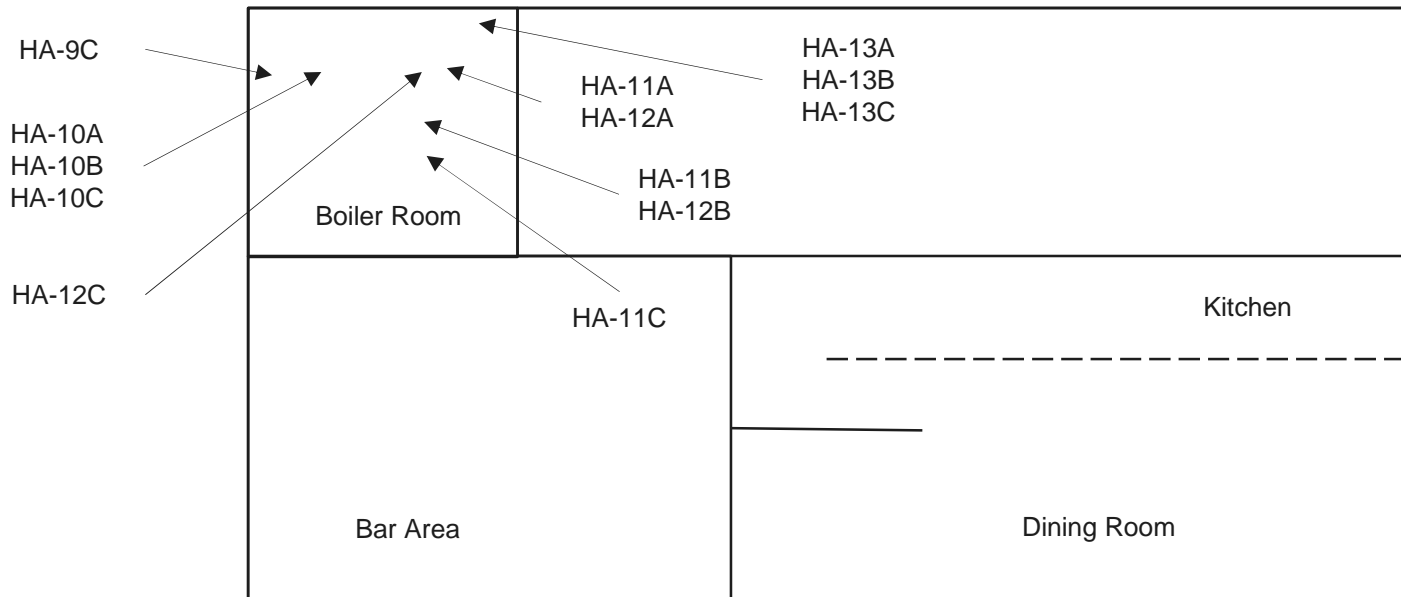
Asbestos Sample Locations Figure

City of Los Angeles Department of Recreations and Parks
Encino Balboa Golf Restaurant – Boiler Room
16821 Burbank Boulevard, Encino, CA 91436

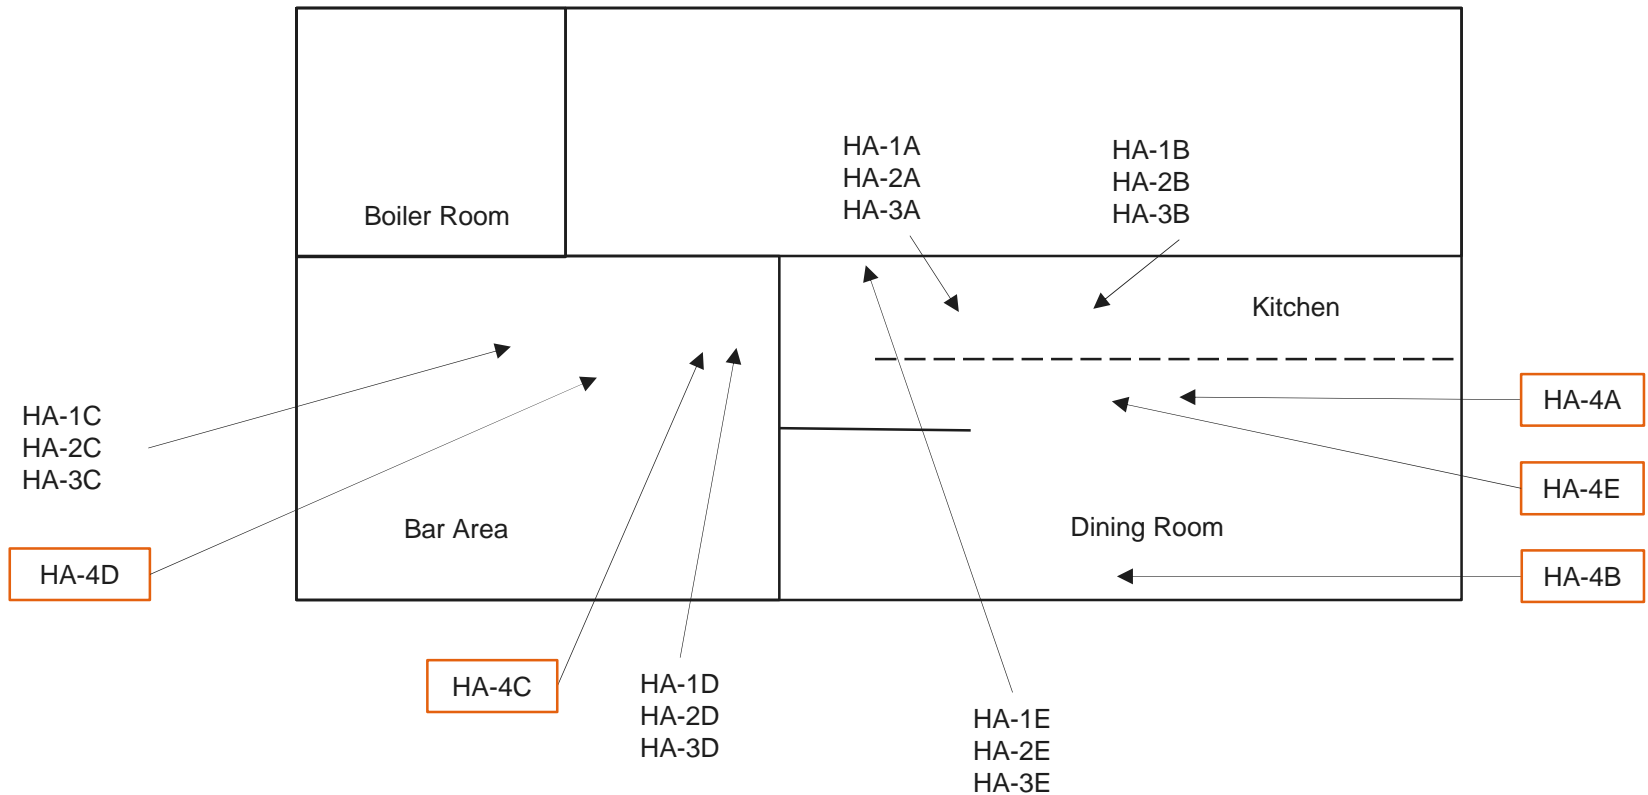
Asbestos Sample Locations Figure

City of Los Angeles Department of Recreations and Parks
Encino Balboa Golf Restaurant – Restaurant
16821 Burbank Boulevard, Encino, CA 91436

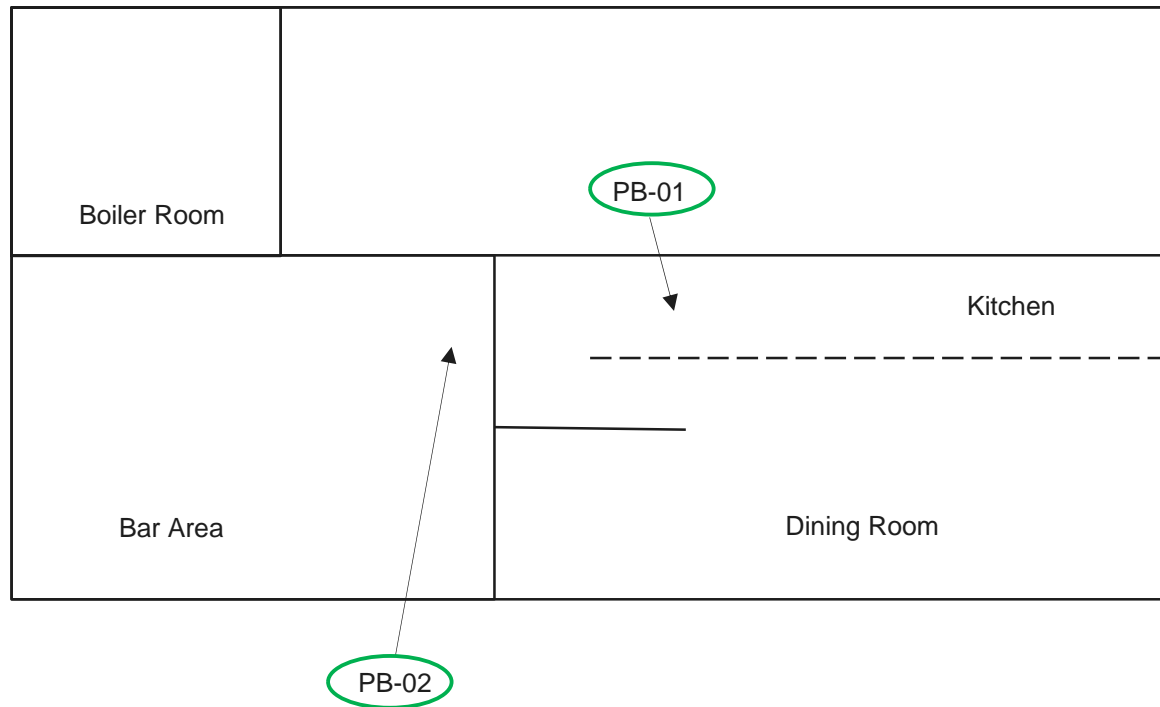
Lead Sample Locations Figure

City of Los Angeles Department of Recreations and Parks
Encino Balboa Golf Restaurant
16821 Burbank Boulevard, Encino, CA 91436

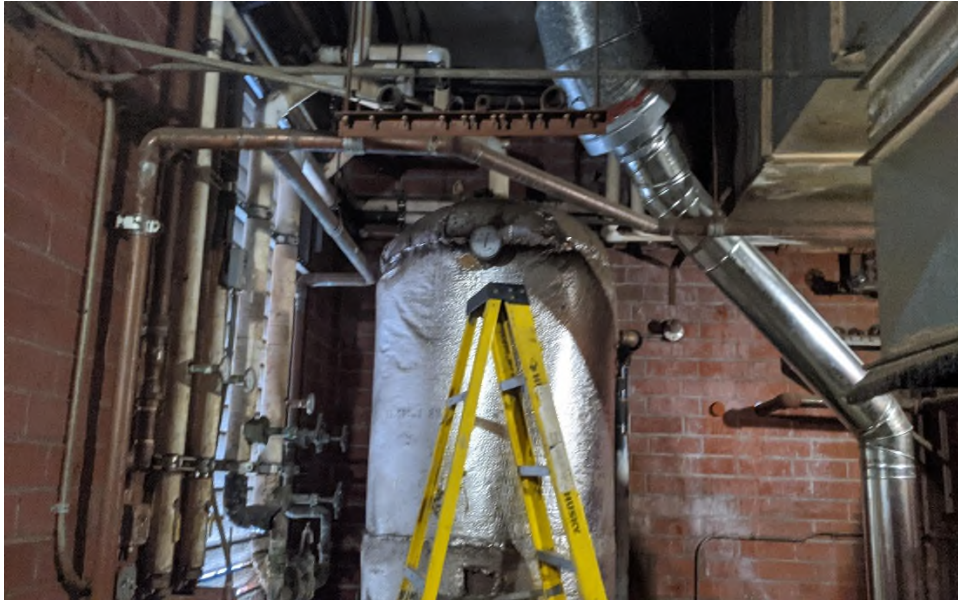
Photograph: 7

Description:
HA-10: Yellow/Silver Boiler
Insulation

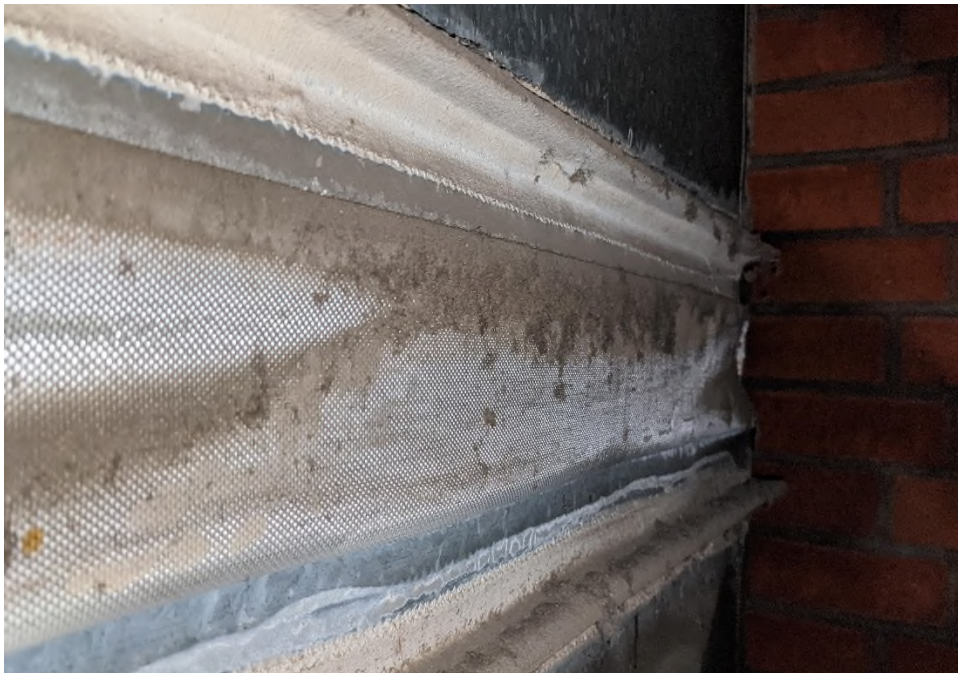
Photograph: 8

Description:
HA-11: Tan HVAC Duct
Tape;
HA-12: Silver/Black HVAC
Vibration Collar

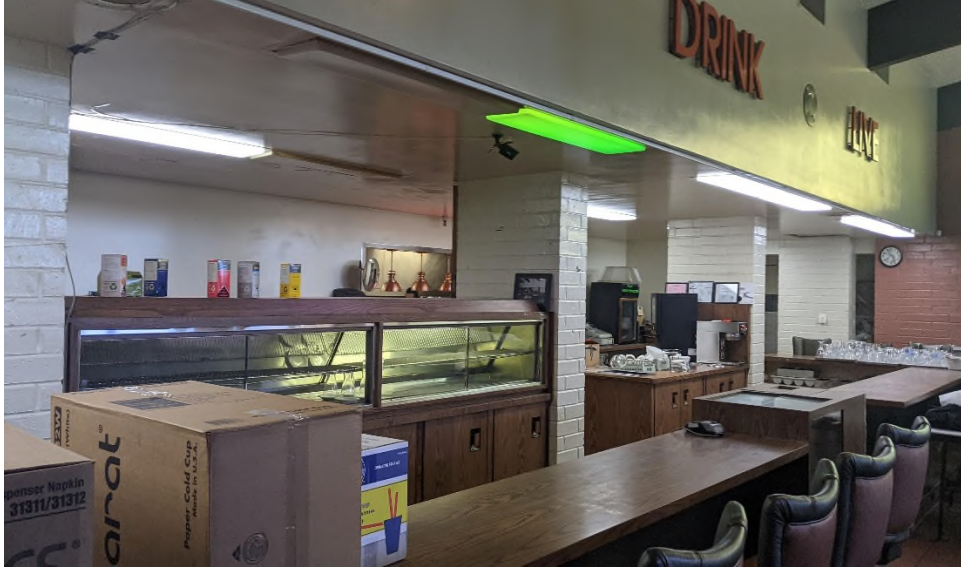
Photograph: 1

Color	Substrate	Lead Content (% WT) *	Area	Quantity	Condition **
Materials Identified as Lead-Containing Paint (<0.5 % WT)					
Off-White	Plaster Ceiling	0.013	Kitchen	190 SF	Intact
Light Blue	Plaster Wall	0.017	Bar Area	190 SF	Intact

Description:
PB-01: Off-White Paint on
Plaster Ceiling

Lead was identified in building surface coatings at the site. Arcadis recommends that any contractor who disturbs lead-containing surfaces be notified of the results and its requirement to comply with the OSHA Lead in Construction Standard, Code of Federal Regulations (CFR), Title 29, 1926.62 and Cal/OSHA Construction Safety Orders, Lead CCR, Title 8, Section 1532.1, effective November 4, 1993 (revised March 7, 1997); specifically, as related to requirements where there may be potential employee exposure.

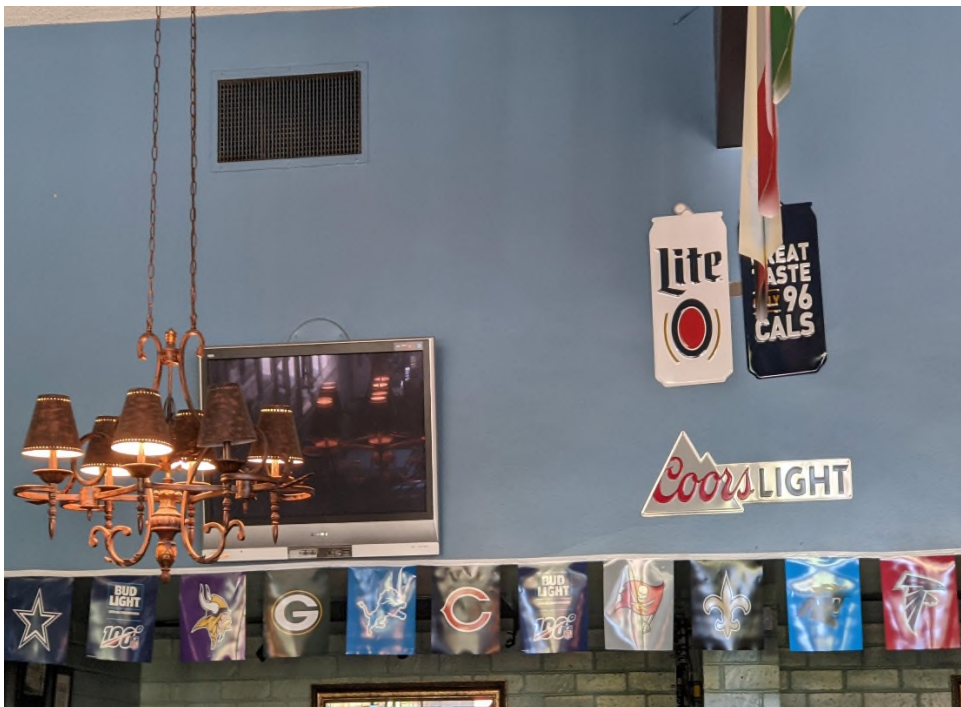
Photograph: 2

Description:
PB-02: Light Blue Paint on
Plaster Wall
