LIMITED ASBESTOS AND LEAD SURVEY

Encino/Balboa Golf Course

Los Angeles County
City of Los Angeles
State of California

October 19, 2003
Volume I of I

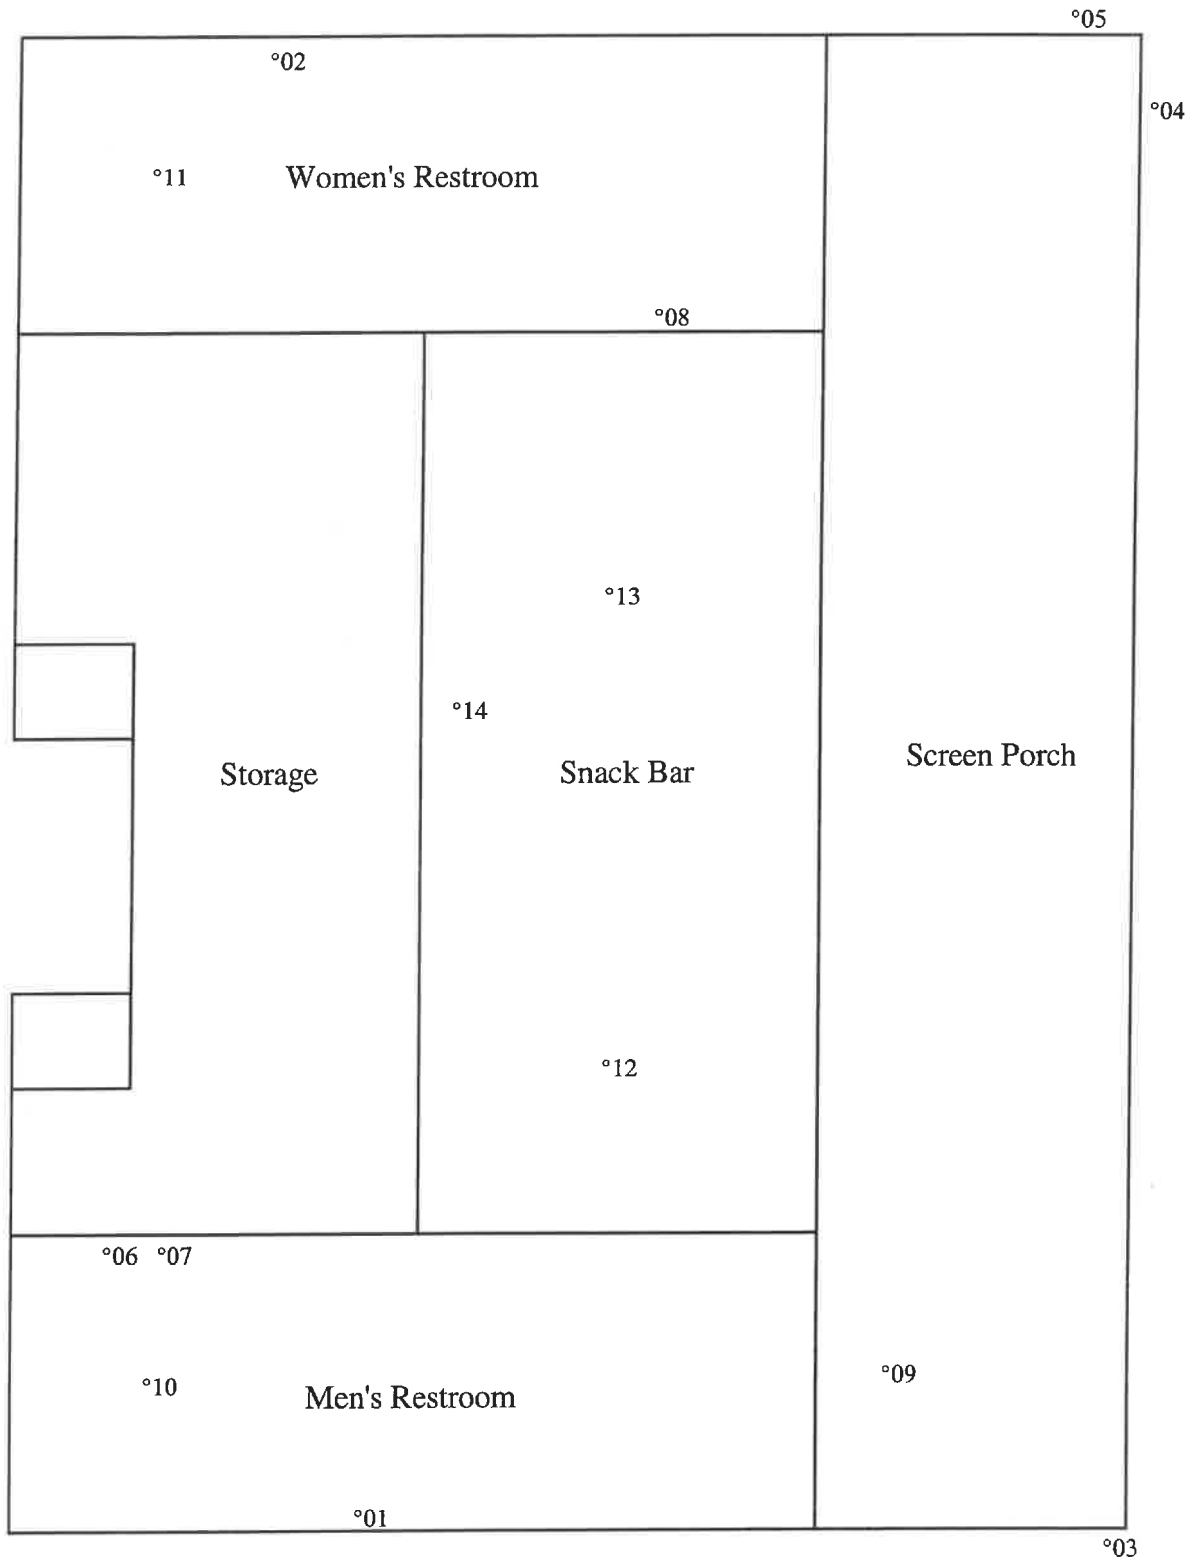
Encino/Balboa Golf Course
Building A

EB-A-11	Built-Up Roofing (Cap Sheet)	Roof	Y	None Detected	N/A	N/A	N/A	N/A	N/A	N/A
EB-A-12	Roof Mastic	Roof	Y	Chrysotile	7	M	NF	GOOD	HIGH	25 SQ. FT.
EB-A-13	Roof Mastic	Roof	Y	None Detected	N/A	N/A	N/A	N/A	N/A	N/A
EB-A-14	Roof Mastic	Roof	Y	Chrysotile	7	M	NF	GOOD	HIGH	REF #12

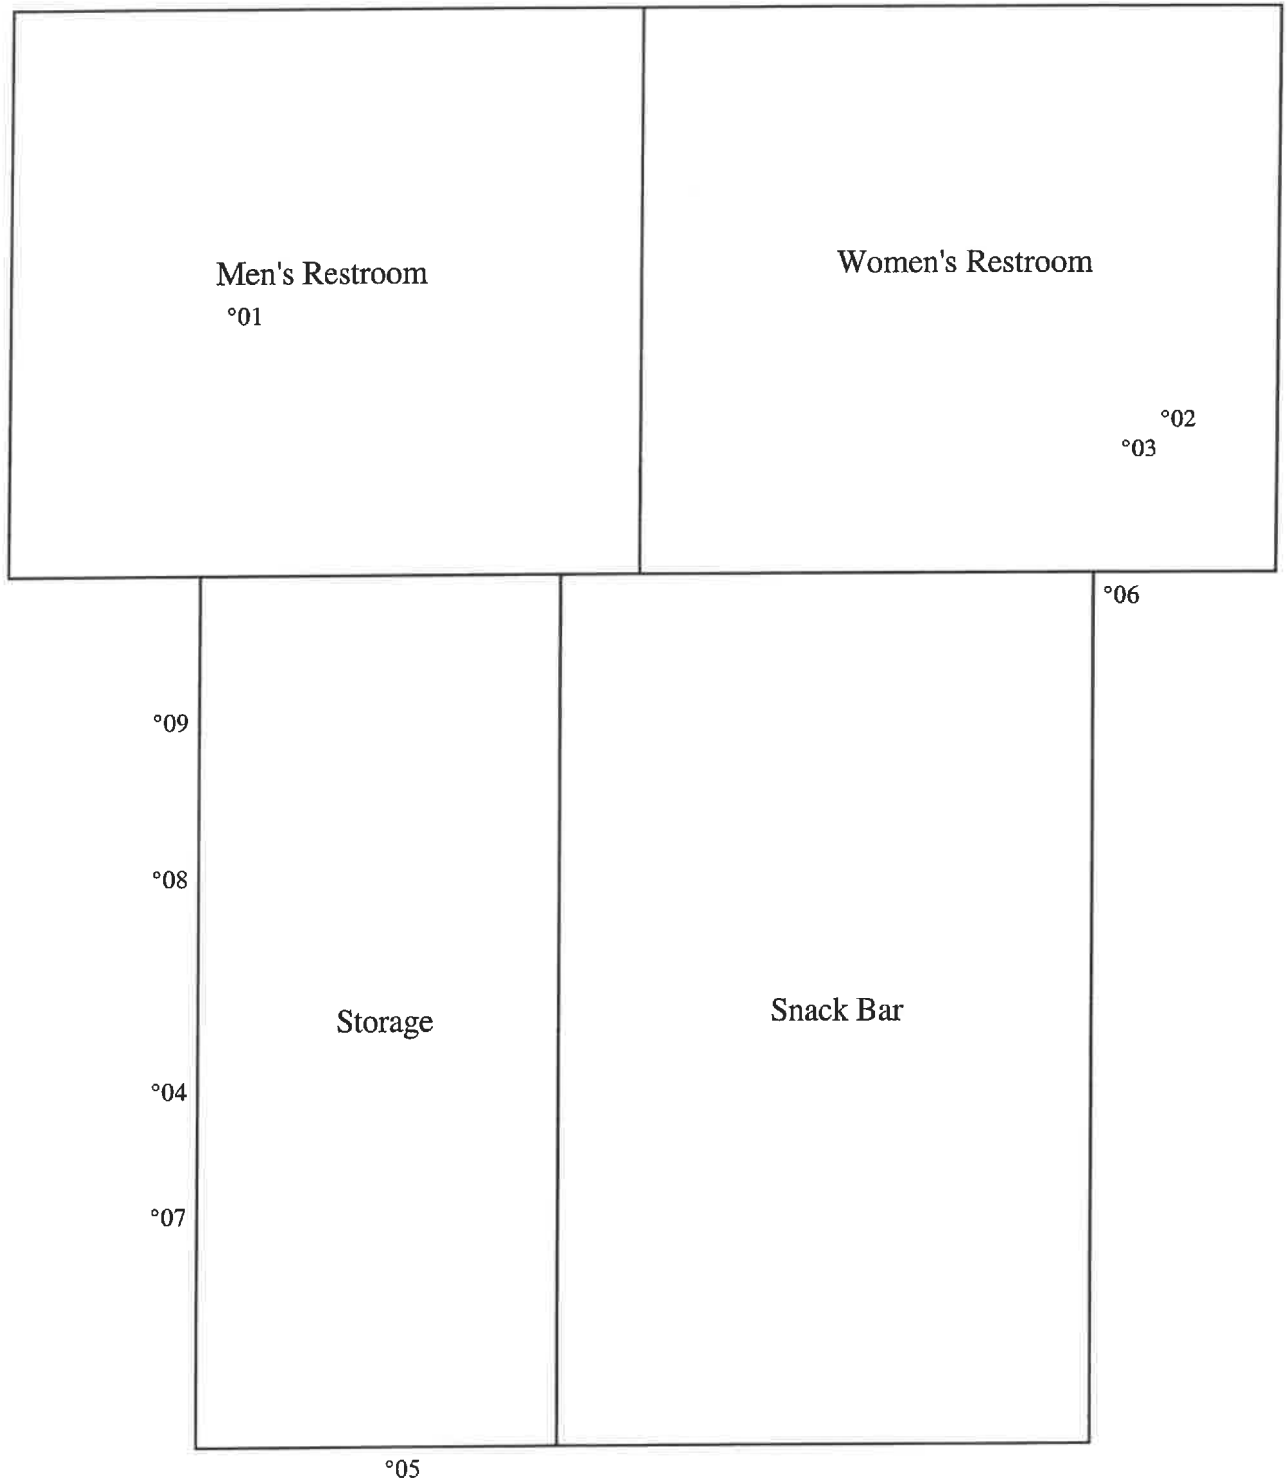
Encino/Balboa Golf Course
Building B

SAMPLE NUMBER	MATERIAL DESCRIPTION	MATERIAL LOCATION	HOMO (1)	ASBESTOS TYPE FOUND	%	S/T/M (2)	F/NF (3)	CONDITION	ACCESSIBILITY	ESTIMATED QUANTITY
EB-A-01	Ceiling Plaster	Men's Restroom Center	Y	Chrysotile	<1	M	NF	FAIR	HIGH	1,000 SQ. FT.
EB-A-02	Ceiling Plaster	Women's Restroom NE Area	Y	Chrysotile	<1	M	NF	FAIR	HIGH	REF #01
EB-A-03	Ceiling Plaster	Women's Restroom NE Area	Y	Chrysotile	3	M	NF	FAIR	HIGH	REF #01
EB-A-04	Stucco	Building Exterior SE Area	Y	None Detected	N/A	N/A	N/A	N/A	N/A	N/A
EB-A-05	Stucco	Building Exterior SE Area	Y	None Detected	N/A	N/A	N/A	N/A	N/A	N/A
EB-A-06	Stucco	Building Exterior NW Area	Y	None Detected	N/A	N/A	N/A	N/A	N/A	N/A
EB-A-07	Window Putty	Building Exterior SE Area	Y	Chrysotile	<1	M	NF	FAIR	HIGH	100 LF
EB-A-08	Window Putty	Building Exterior Mid. S Area	Y	Chrysotile	<1	M	NF	FAIR	HIGH	REF #07
EB-A-09	Window Putty	Building Exterior SW Area	Y	Chrysotile	<1	M	NF	FAIR	HIGH	REF #07

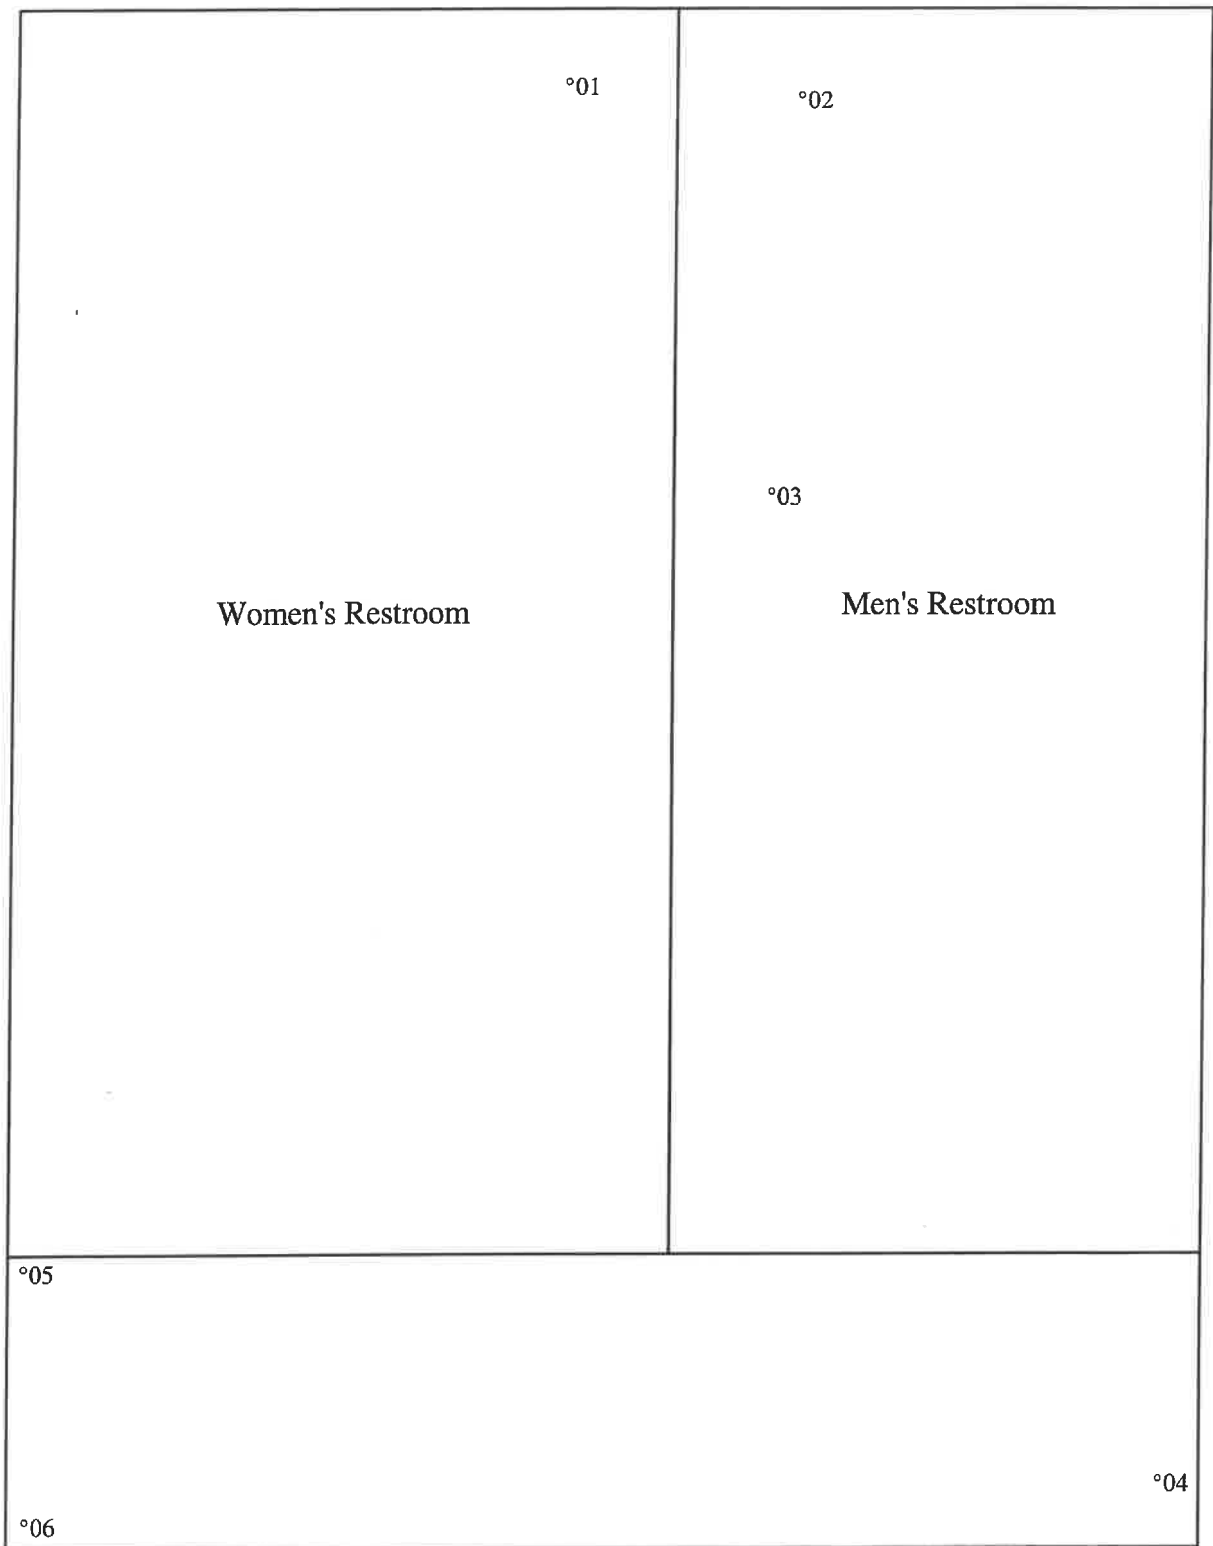
Encino/Balboa Golf Course
Building C

SAMPLE NUMBER	MATERIAL DESCRIPTION	MATERIAL LOCATION	HOMO (1)	ASBESTOS TYPE FOUND	%	S/T/M (2)	F/NF (3)	CONDITION	ACCESSIBILITY	ESTIMATED QUANTITY
EB-A-01	Ceiling Plaster	Women's Restroom NW Area	Y	Chrysotile	<1	M	NF	GOOD	HIGH	1,500 SQ. FT.
EB-A-02	Ceiling Plaster	Men's Restroom SW Area	Y	Chrysotile	<1	M	NF	GOOD	HIGH	REF #01
EB-A-03	Ceiling Plaster	Men's Restroom Mid. S Area	Y	Chrysotile	<1	M	NF	GOOD	HIGH	REF #01
EB-A-04	Stucco	Arcade NE Area	Y	Chrysotile	<1	M	NF	GOOD	HIGH	400 SQ. FT.
EB-A-05	Stucco	Arcade SW Area	Y	Chrysotile	<1	M	NF	GOOD	HIGH	REF #04
EB-A-06	Stucco	Arcade SE Area	Y	Chrysotile	<1	M	NF	GOOD	HIGH	REF #04

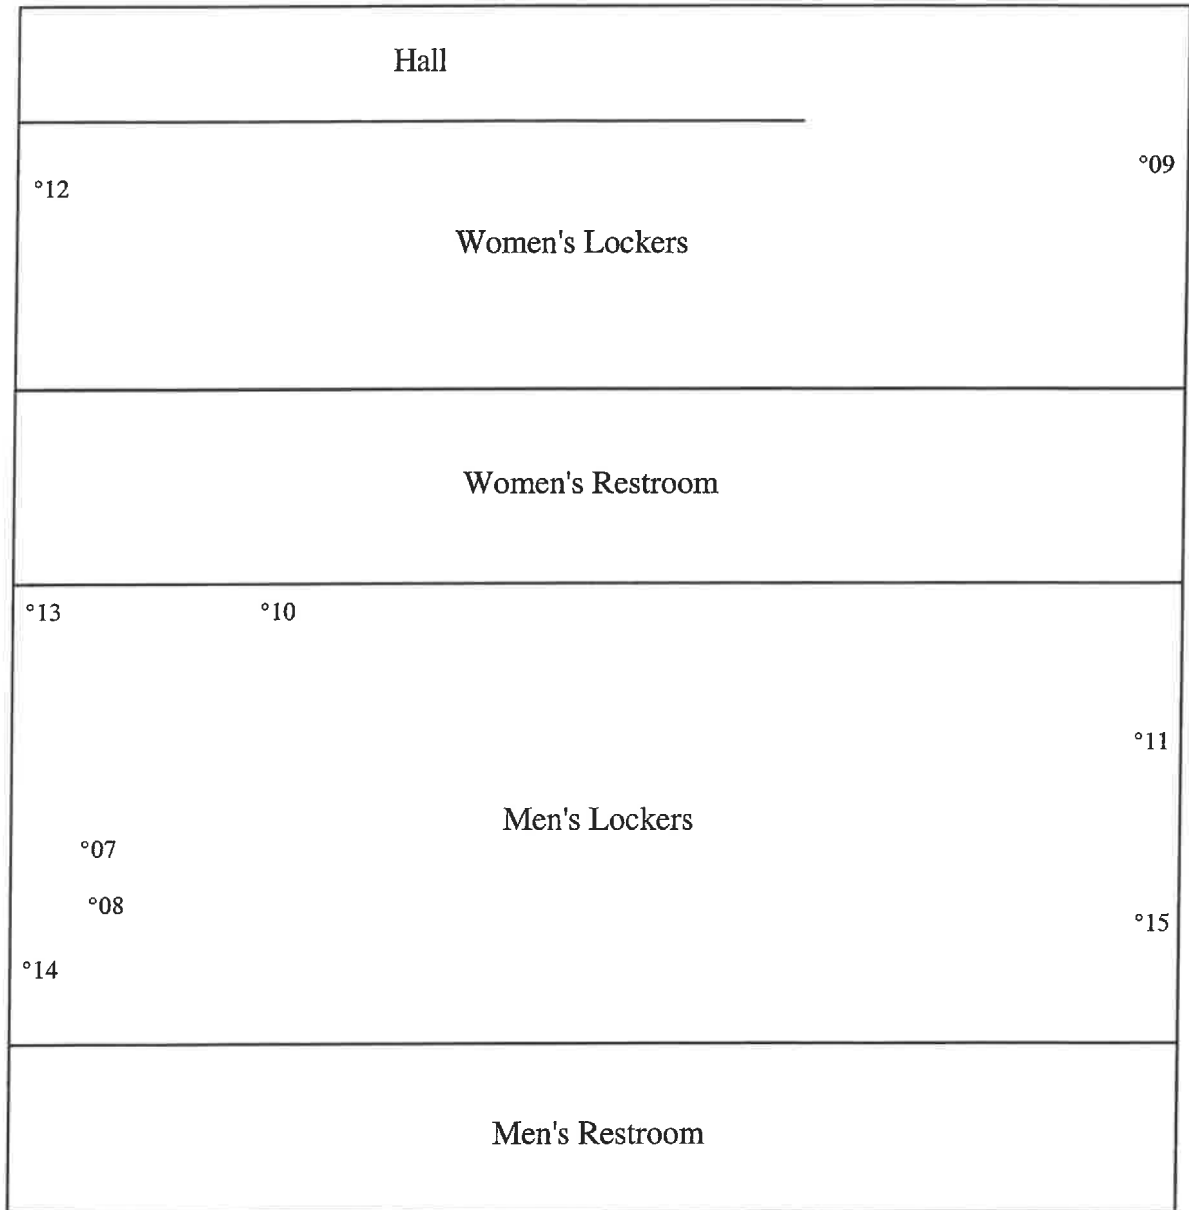
Encino/Balboa Golf Course
Building D

SAMPLE NUMBER	MATERIAL DESCRIPTION	MATERIAL LOCATION	HOMO (1)	ASBESTOS TYPE FOUND	%	S/T/M (2)	F/NF (3)	CONDITION	ACCESSIBILITY	ESTIMATED QUANTITY
EB-A-07	Acoustical Spray-On	Men's Locker Room NW Area	Y	Chrysotile	7	S	F	GOOD	HIGH	4,000 SQ. FT.
EB-A-08	Acoustical Spray-On	Men's Locker Room NW Area	Y	Chrysotile	7	S	F	GOOD	HIGH	REF #07
EB-A-09	Acoustical Spray-On	Women's Locker Room SE Area	Y	Chrysotile	7	S	F	GOOD	HIGH	REF #07
EB-A-10	Drywall (Composite)	Men's Locker Room NE Area	Y	None Detected	N/A	N/A	N/A	N/A	N/A	N/A
EB-A-11	Drywall (Composite)	Men's Locker Room SE Area	Y	None Detected	N/A	N/A	N/A	N/A	N/A	N/A
EB-A-12	Drywall (Composite)	Women's Locker Room NE Area	Y	None Detected	N/A	N/A	N/A	N/A	N/A	N/A
EB-A-13A	Cove Base	Men's Locker Room NE Area	Y	None Detected	N/A	N/A	N/A	N/A	N/A	N/A
EB-A-13B	Cove Base Mastic	Men's Locker Room NE Area	Y	None Detected	N/A	N/A	N/A	N/A	N/A	N/A
EB-A-14A	Cove Base	Men's Locker Room NW Area	Y	None Detected	N/A	N/A	N/A	N/A	N/A	N/A

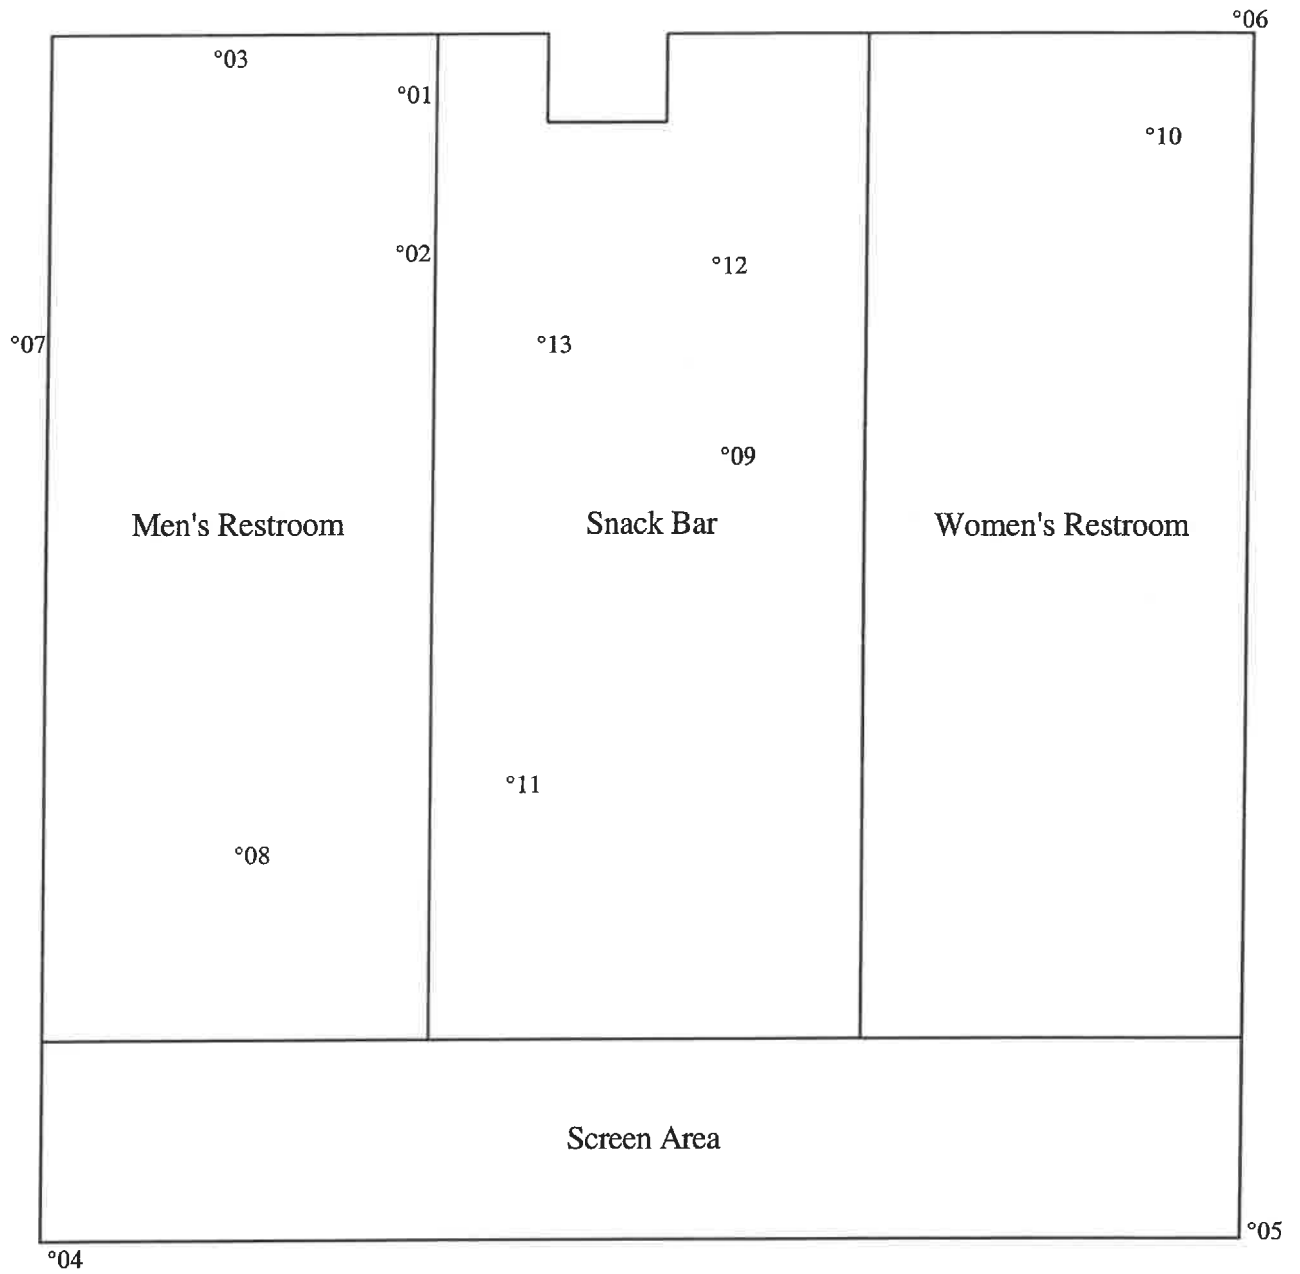
Encino/Balboa Golf Course
Building E

EB-A-09B	Built-Up Roofing (2 nd Layer)	Roof Center	Y	None Detected	N/A	N/A	N/A	N/A	N/A	N/A
EB-A-10A	Built-Up Roofing (Cap Sheet)	Roof NW Area	Y	None Detected	N/A	N/A	N/A	N/A	N/A	N/A
EB-A-10B	Built-Up Roofing (2 nd Layer)	Roof NW Area	Y	None Detected	N/A	N/A	N/A	N/A	N/A	N/A
EB-A-11	Roof Mastic	Roof SE Area	Y	None Detected	N/A	N/A	N/A	N/A	N/A	N/A
EB-A-12	Roof Mastic	Roof NW Area	Y	None Detected	N/A	N/A	N/A	N/A	N/A	N/A
EB-A-13	Roof Mastic	Roof SW Area	Y	Chrysotile	7	M	NF	GOOD	HIGH	50 SQ. FT.
