HISTORIC STRUCTURE REPORT (UPDATED JUNE 2009)

Wattles Mansion

HISTORIC RESOURCES GROUP

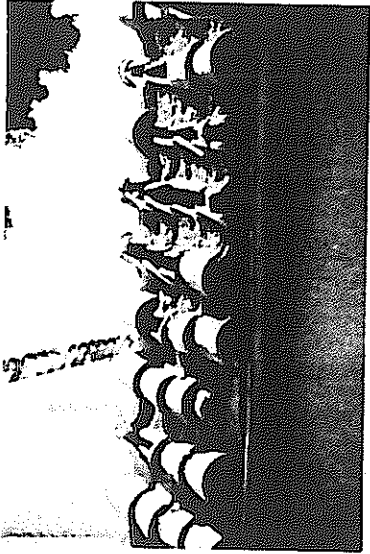
Damaged and missing clay tiles.

with an asphalt sheet which, in some locations, provides the only waterproofing of the surface.

Water can now penetrate the mansion roof through the spaces between the remaining tiles. It is surprising that there is not more evidence of leaks and water damage in the occupied spaces below. Some loss of paint on the walls and ceilings of these rooms may be due to moisture from the roof. (Note: In 1992, a new built-up roof was installed, the perimeter parapet tiles were removed, the underlayment replaced and the tiles re-installed.)

2. Remove all roof tiles and asphalt sheathing below. Save all tile for reinstallation. Remove all deteriorated flashing and counter-flashing. Inspect wood sheathing and trim for rot and insect damage and replace deteriorated elements. Remove and replace built-up roofing. Reinstall existing tiles on the mansion and west addition, over felt, using wire ties. Install new tile, custom-made to match existing, if possible, in less-visible locations and on the caretaker's cottage. Add new flashing at top of tile parapet around the perimeter of flat roof area on the mansion and west addition; repair or replace copper flashing at the ridge of the caretaker's cottage. Repair roof drains, replacing screens. Repair flashing at all roof penetrations. Extend vents to height required by code. Repair roof hatch and scuttle as required. Point, patch cracks, and provide seismic reinforcement for the chimney. (Note: This work was accomplished in 1992.)

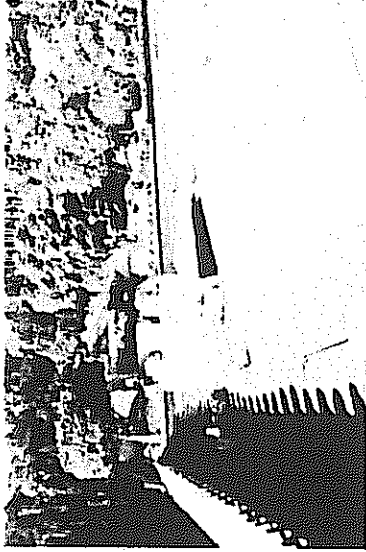
Composition roof and clay tile parapet.

entirely copper. (Note: A new built-up roof, new roof drains, and new flashings were installed in 1992.)

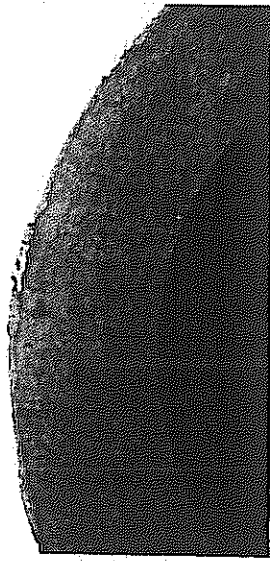
Downspouts terminate at grade or continue down into the soil. It was not possible to observe whether the buried ends of the pipes connect to a below-grade drainage system or simply discharge into the ground below grade. However, in at least one location, at the north wall of the basement stair, there has been severe water damage inside the mansion. Either the pipe simply drains into the ground outside this wall or there is a faulty connection with the underground piping resulting in a leak that has led to the interior damage. Other areas have the same configuration but exhibit no damage.

There is also some settlement of paved areas around the mansion, particularly at the front (south) terrace, possibly due to the accumulation of drainage water below the paving.

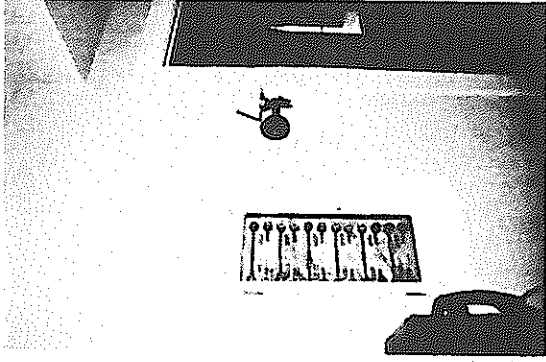
Marble-faced electrical panel.

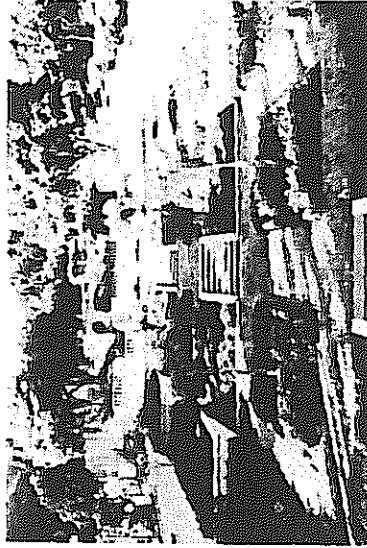
Terraced Garden looking north.

The high walls to the east and west are missing much of their tile cap, but their plaster finish seems to be in good condition. The lower walls and

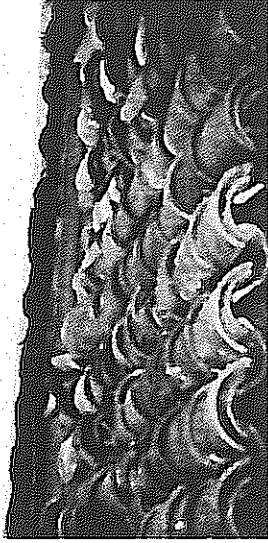
Loose clay tiles.

and replace built-up roofing. Reinstall existing tiles on the mansion and west addition, over felt, using wire ties. (1992.)
