HISTORIC STRUCTURE REPORT (UPDATED JUNE 2009)

Wattles Mansion

HISTORIC RESOURCES GROUP

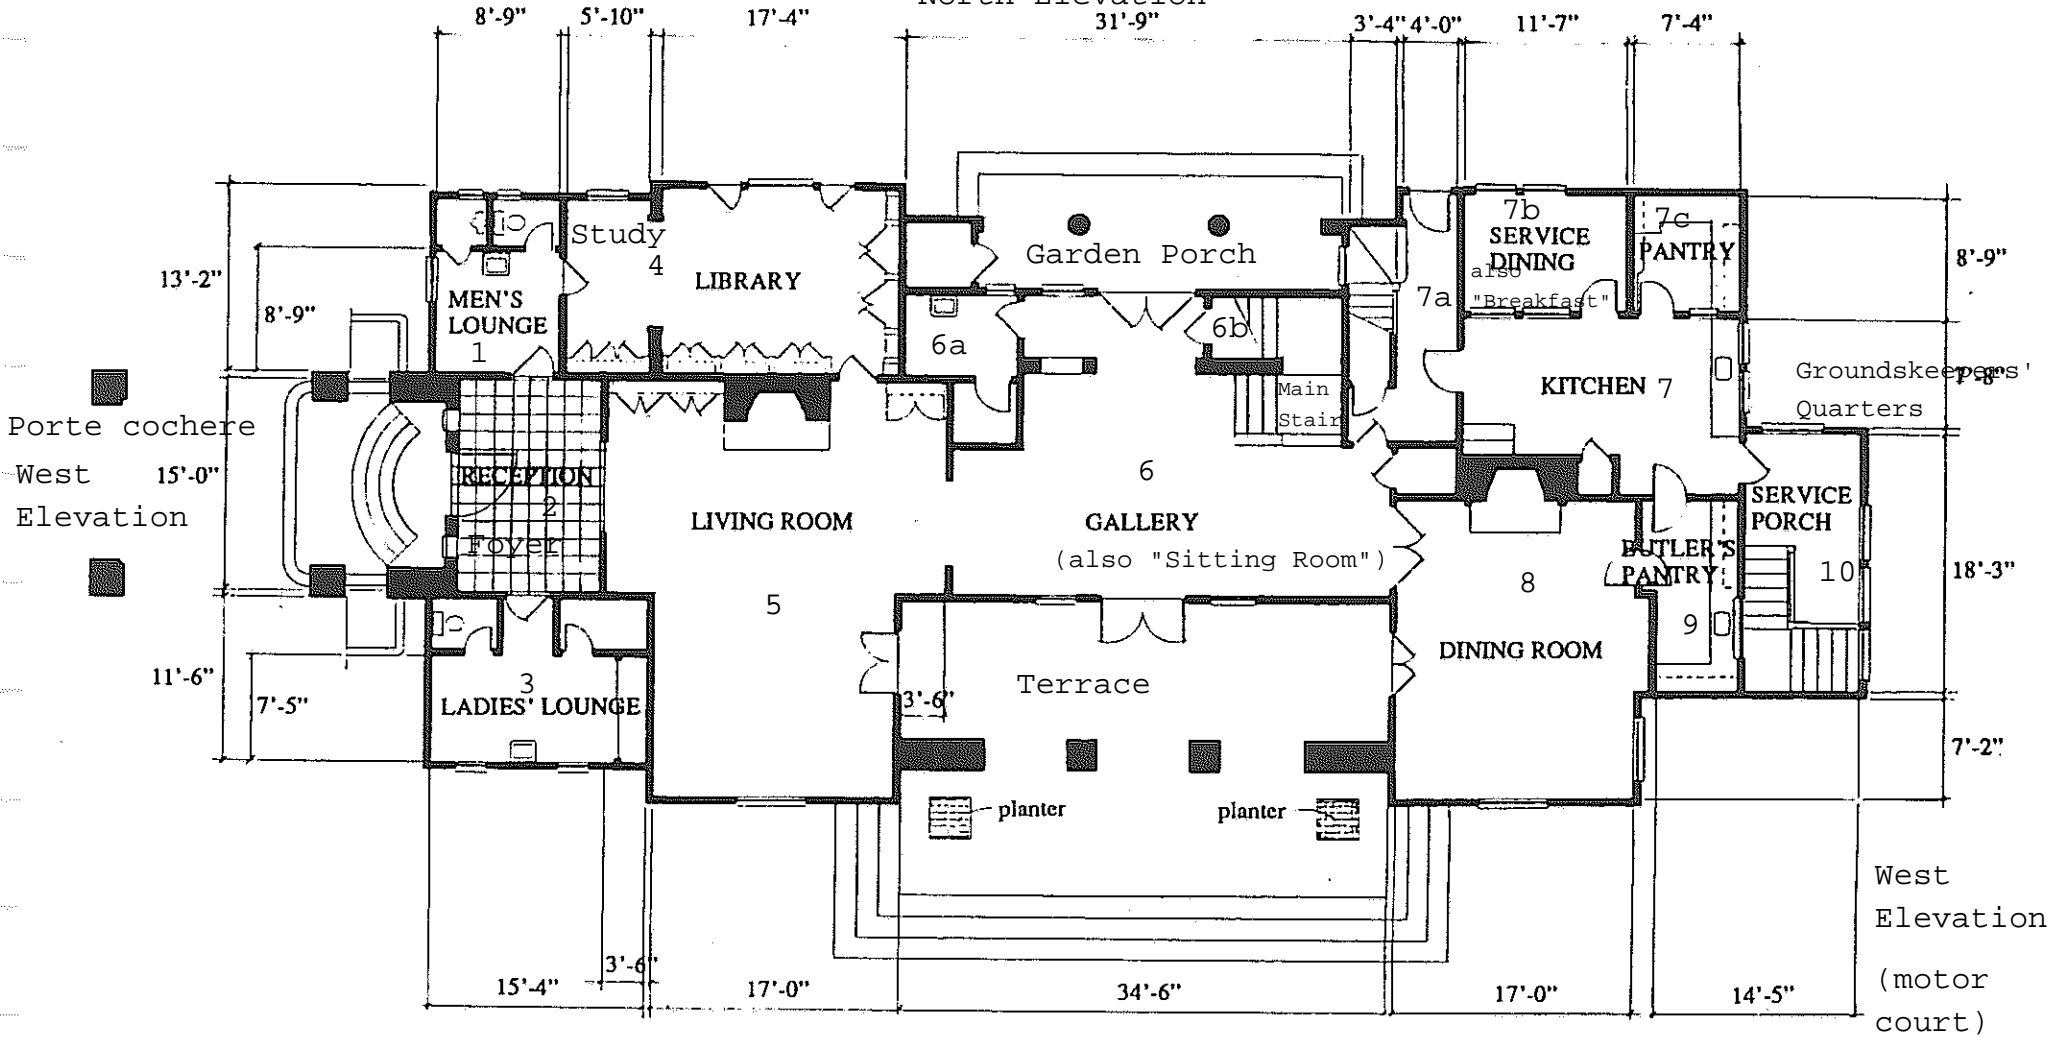
Figure 1: FIRST FLOOR PLAN

rear of the mansion, is a small garden/dark room, currently used for storage. A stair in the northeast corner of the gallery leads to the second floor. At the east end, the gallery opens into the main dining room, as well as the service hall connecting to the kitchen and an enclosed back stair that leads to the partial basement and the second floor. Off the kitchen are a service dining room, a pantry, a butler's pantry (leading back into the dining room) and the service porch of the east elevation. (See Floor Plans, Figure 1.)

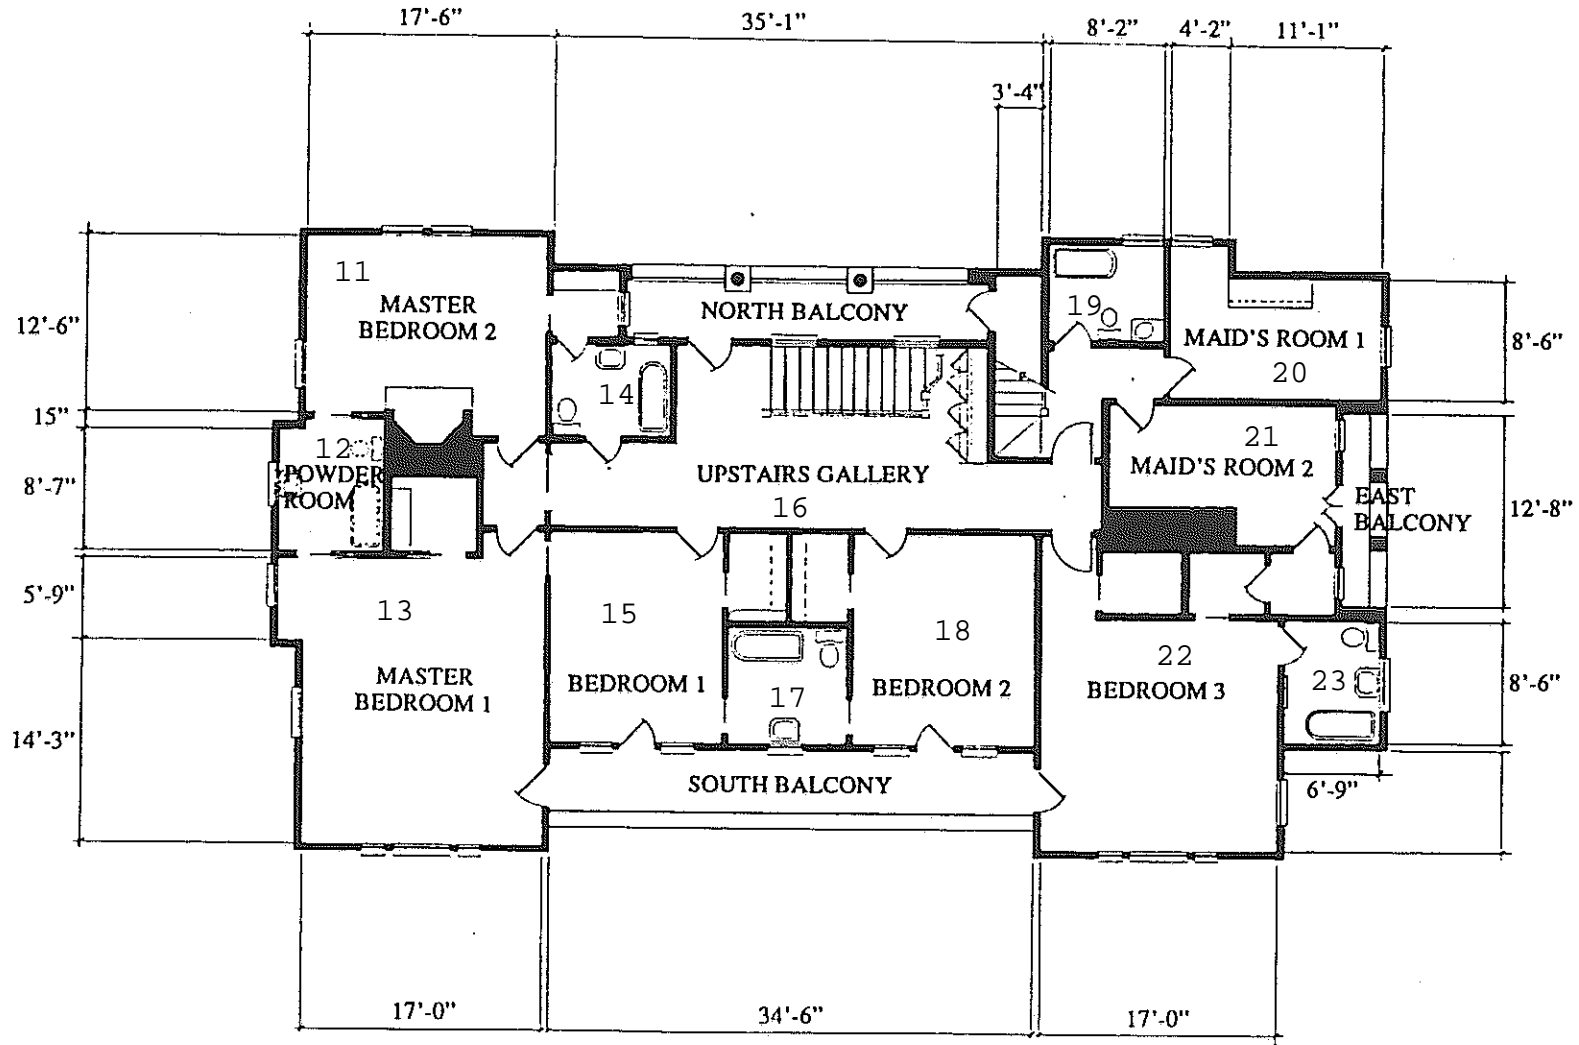
Figure 2: SECOND FLOOR PLAN

(See Floor Plans, Figure 2.)

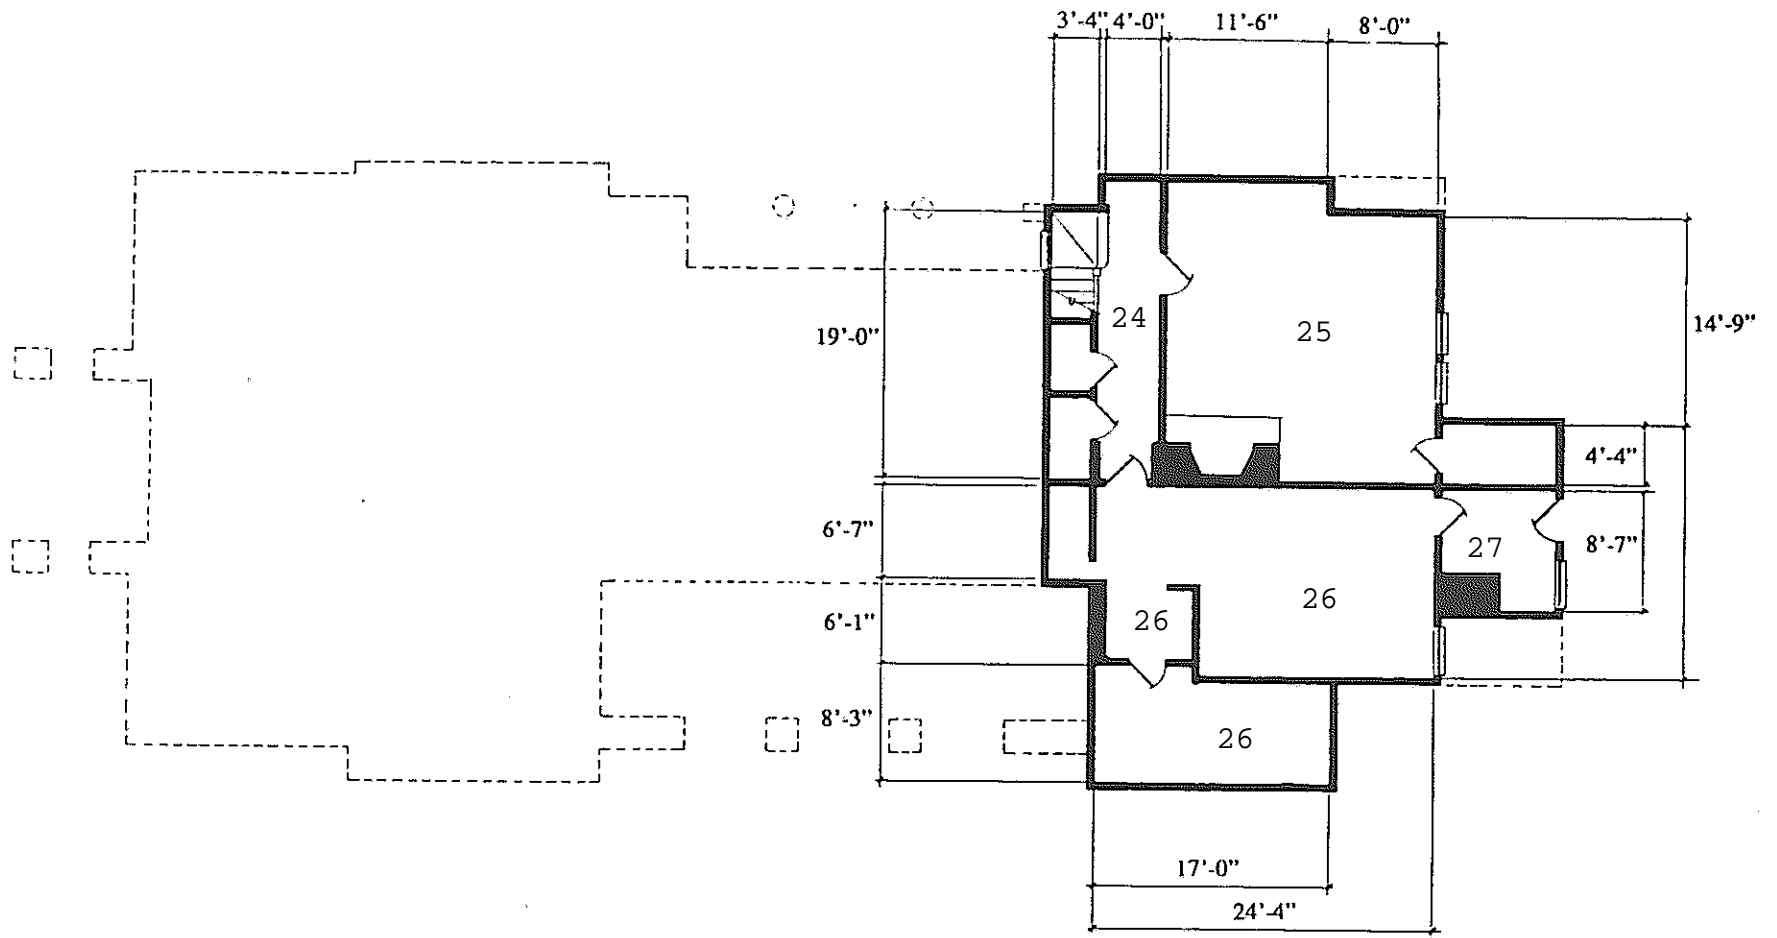
Figure 3: PARTIAL BASEMENT PLAN

The partial basement may be reached by the rear service stair from the first floor or an exterior door on the east elevation. Most of the basement is used for storage and mechanical equipment, although a billiard room or game room looks out into the light well between the mansion and the adjacent caretaker's cottage. (See Floor Plans, Figure 3.)
