SUBJECT: RITCHIE VALENS RECREATION CENTER SPORTS COURT LIGHTING (W.O. #E170510) PROJECT (AKA PROP K SPORTS LIGHTING IMPROVEMENT: RITCHIE VALENS RECREATION CENTER) – FINAL ACCEPTANCE

**PROP K SPORTS  
LIGHTING IMPROVEMENT:  
RITCHIE VALENS RECREATION CENTER**

**RITCHIE VALENS PARK - SPORTS LIGHTING PROJECT**  
**10731 LAUREL CANYON BOULEVARD, LOS ANGELES, CA 91331**  
**W.O. E170510D** **GED FILE NO. 17-169**

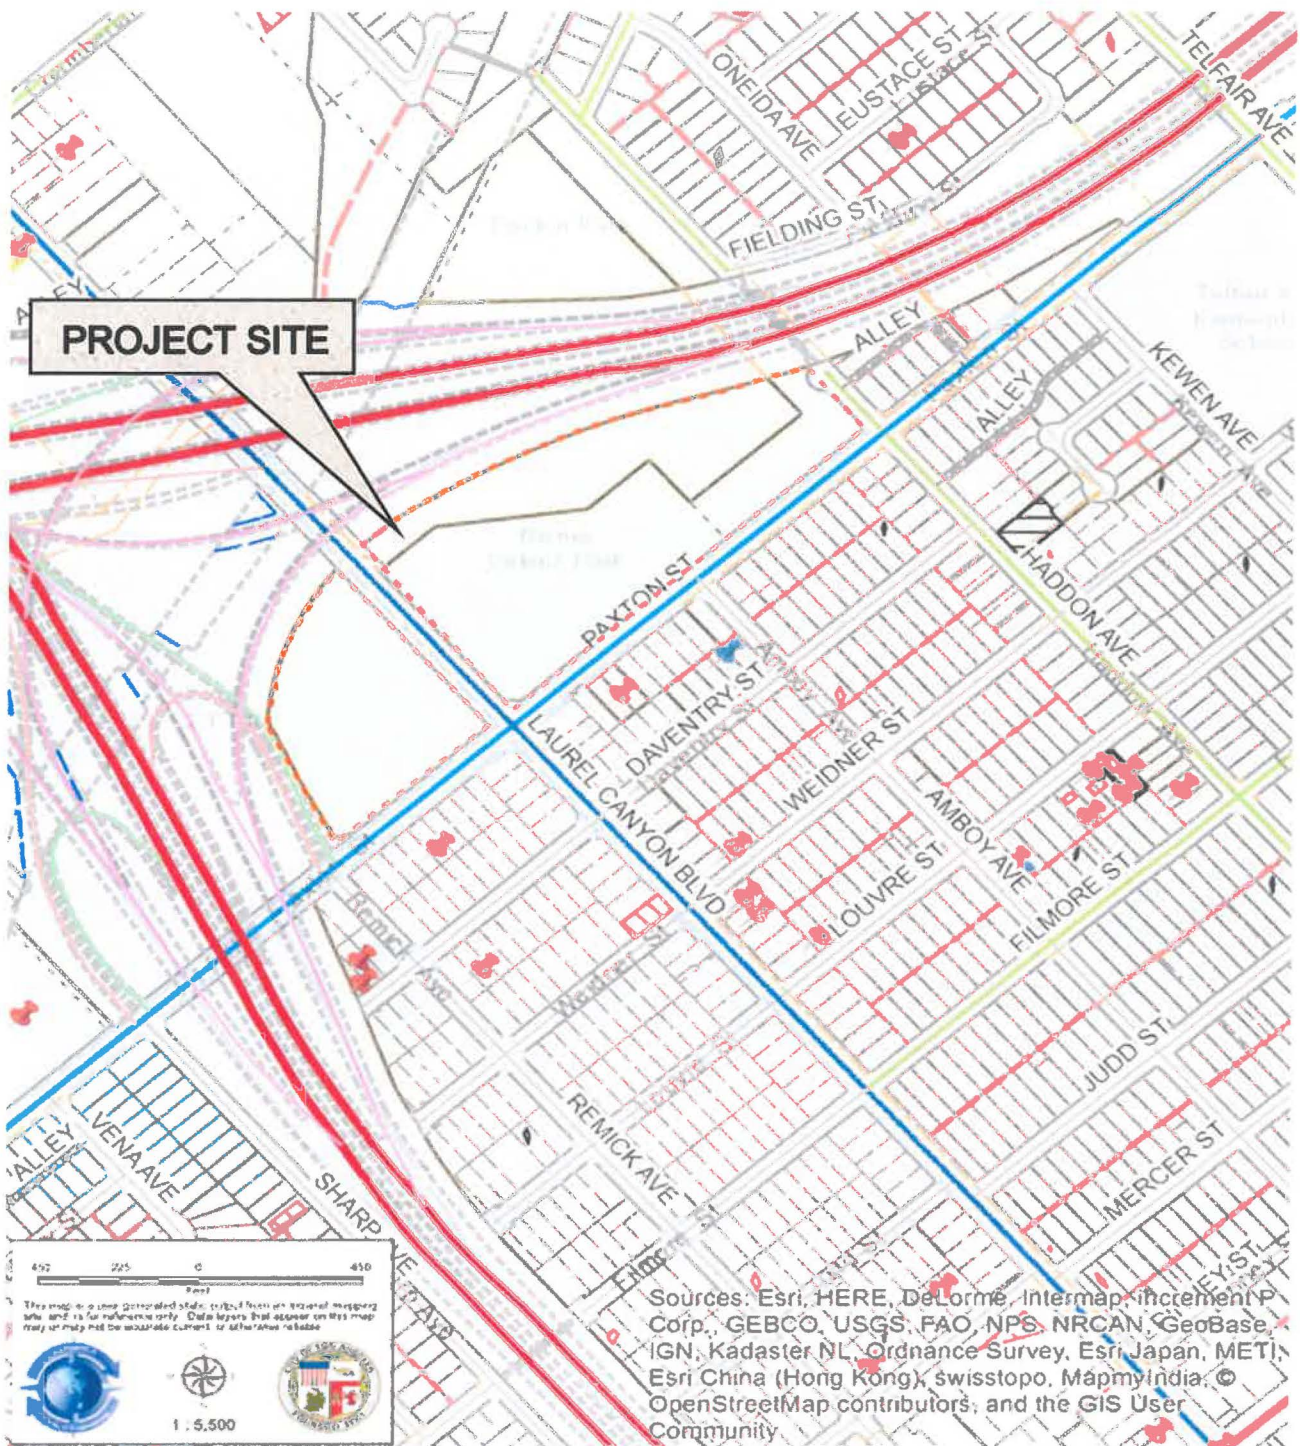
## VICINITY MAP

The Los Angeles Department of Public Works, Bureau of Engineering, Geotechnical Engineering Division (GED) has prepared this report to provide design and construction recommendations for the project. The project site, as shown on Figure 1 – Vicinity Map, is located at the intersection of Laurel Canyon Boulevard and Paxton Street in the Pacoima City area of Los Angeles.

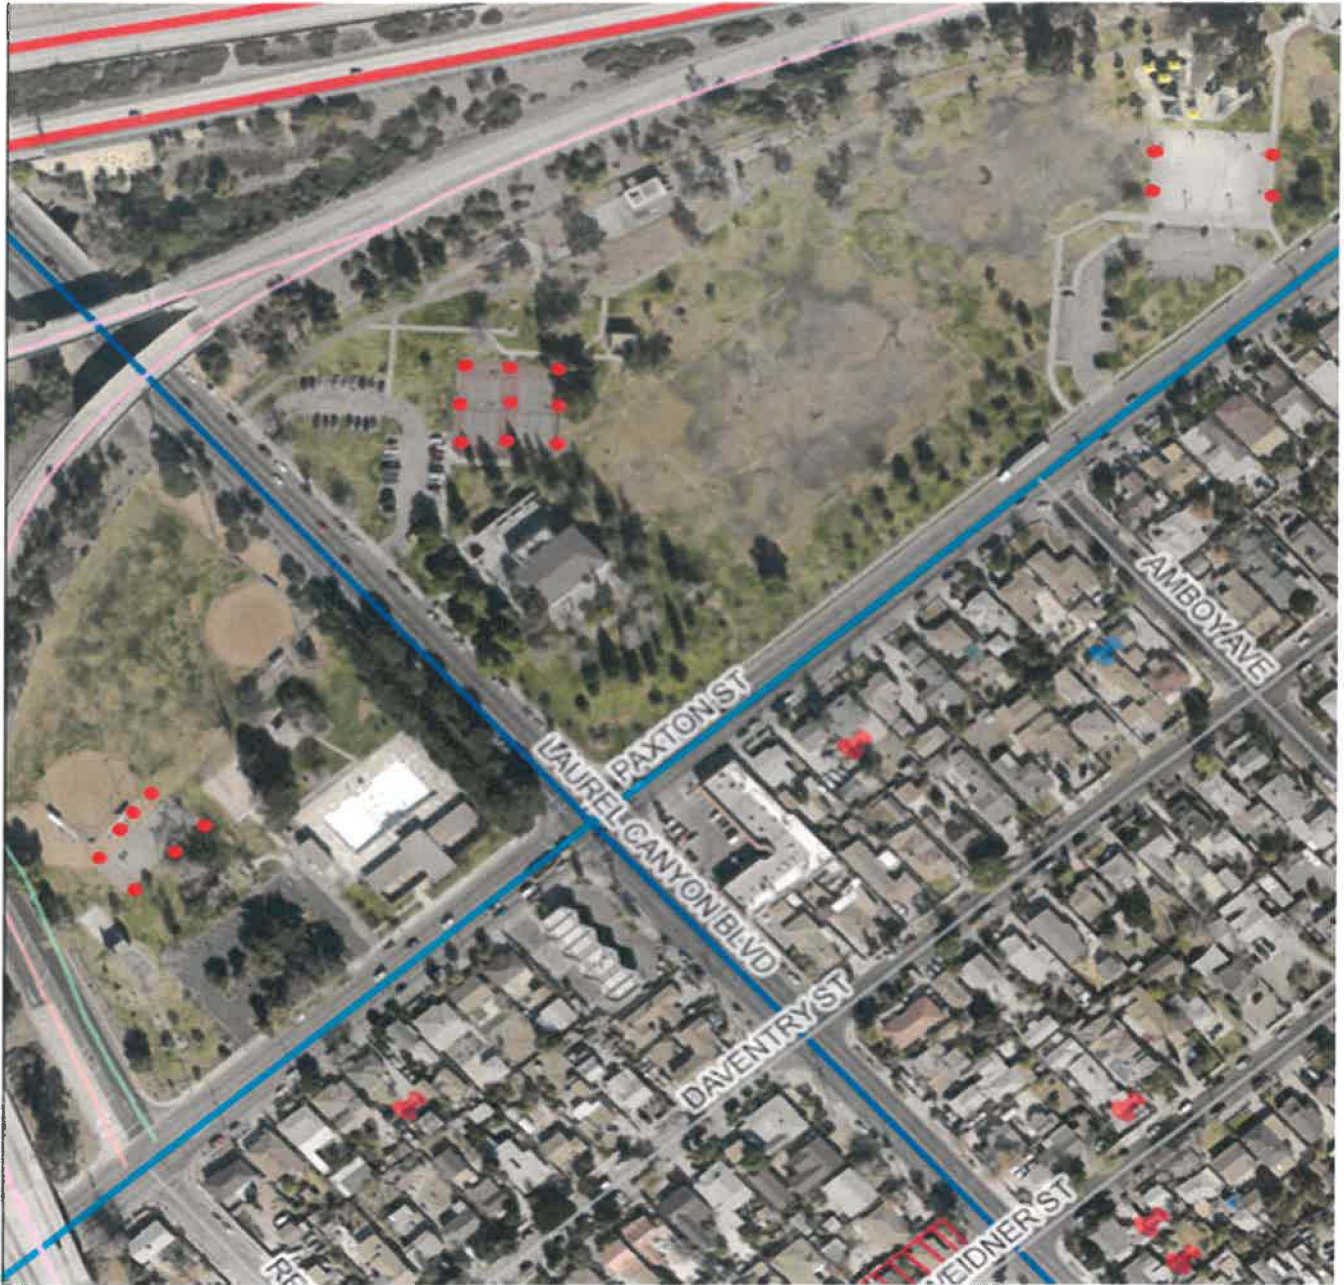
**Figure**  
**No. 2**

- Existing light pole location ~ 60-feet high

# SITE LOCATION MAP

The project site, including the existing light pole locations, is presented on Figure 2 – Site Location Map. The project consists of replacing the existing tennis court lights and basketball court lights with new ones. We understand the proposed LED light poles for both the tennis and basketball courts, including the fixtures may be up to approximately 50 feet high.

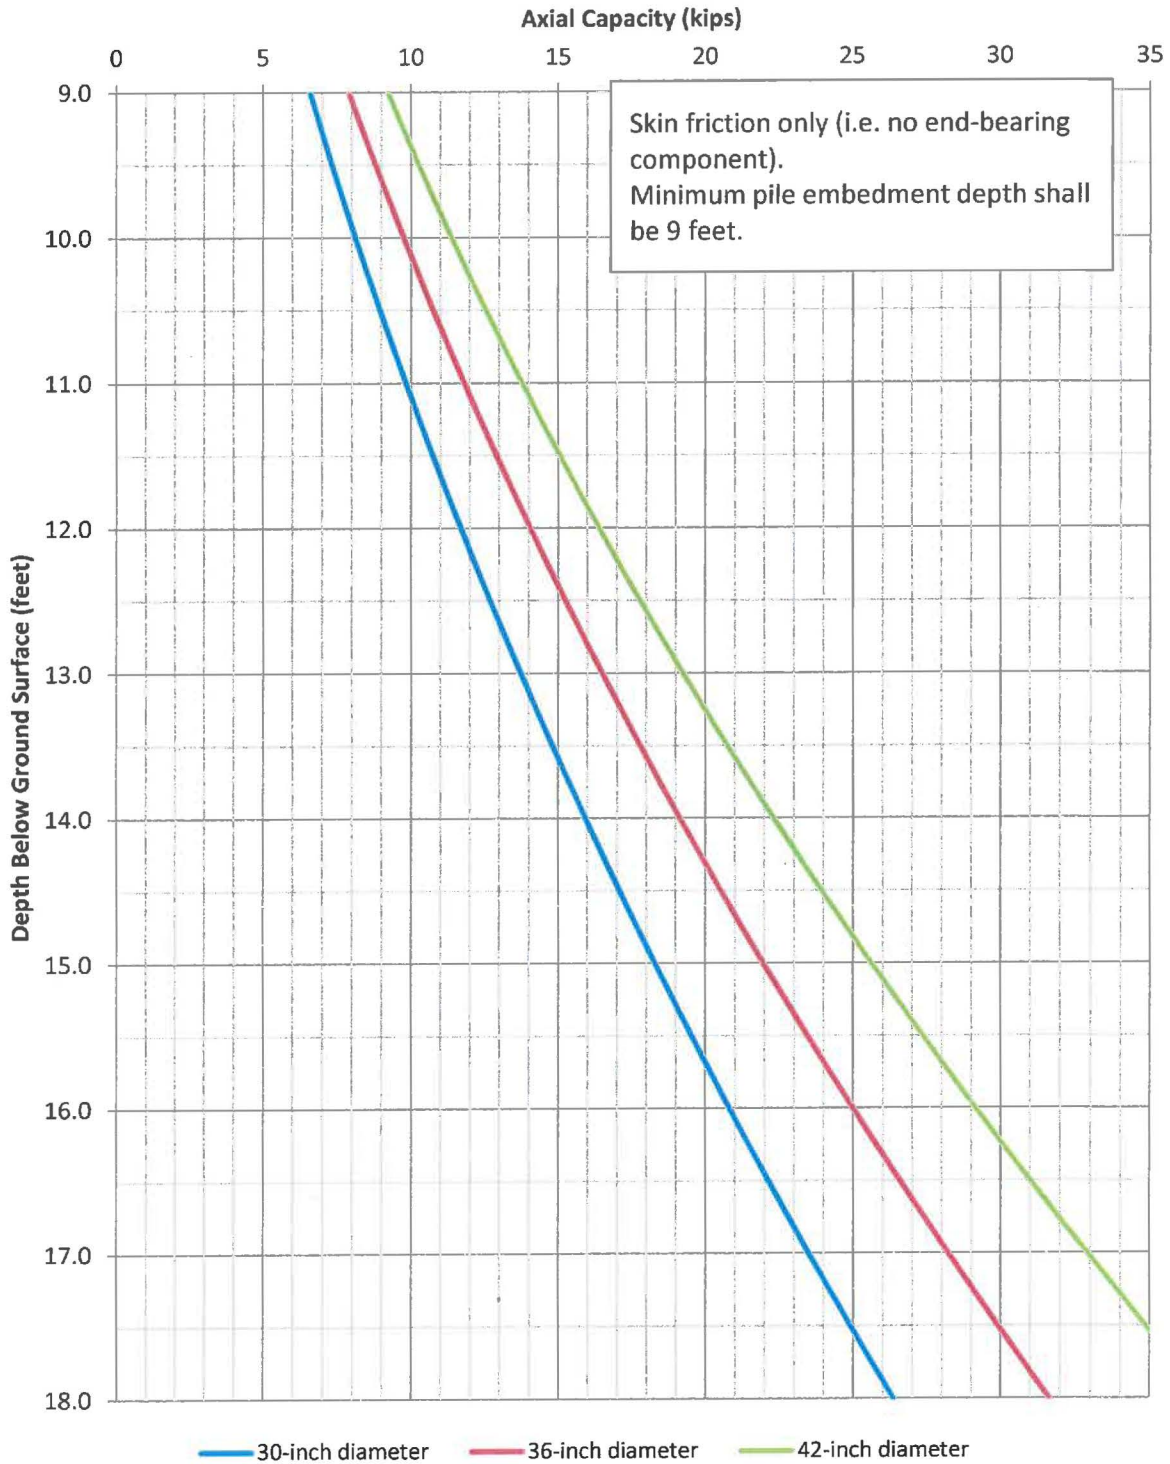
# Allowable Downward Capacity of CIDH Pile vs. Depth

Figure 3 – Allowable Downward Capacity of CIDH Pile vs. Depth

The minimum pile embedment depth shall be 9 feet below the lowest adjacent grade. The actual depths may be deeper and will likely depend on the lateral load analysis, which shall be performed by the structural engineer. Axial compression capacities (i.e. loads) are presented on Figure 3 for a 30-inch, 36-inch, and 42-inch diameter CIDH piles. The axial compression capacities presented in Figure 3 assume the piles develop their capacity solely from skin friction or side resistance. The total settlement is not expected to exceed ½-inch provided the piles are properly constructed (see Section 4.2.5).

The allowable axial tensile capacity may be assumed to be ½ the axial capacity in compression for the 30-inch, 36-inch, and 42-inch diameter CIDH piles (Figure 3). The weight of the concrete shaft may be added to the tensile capacity.

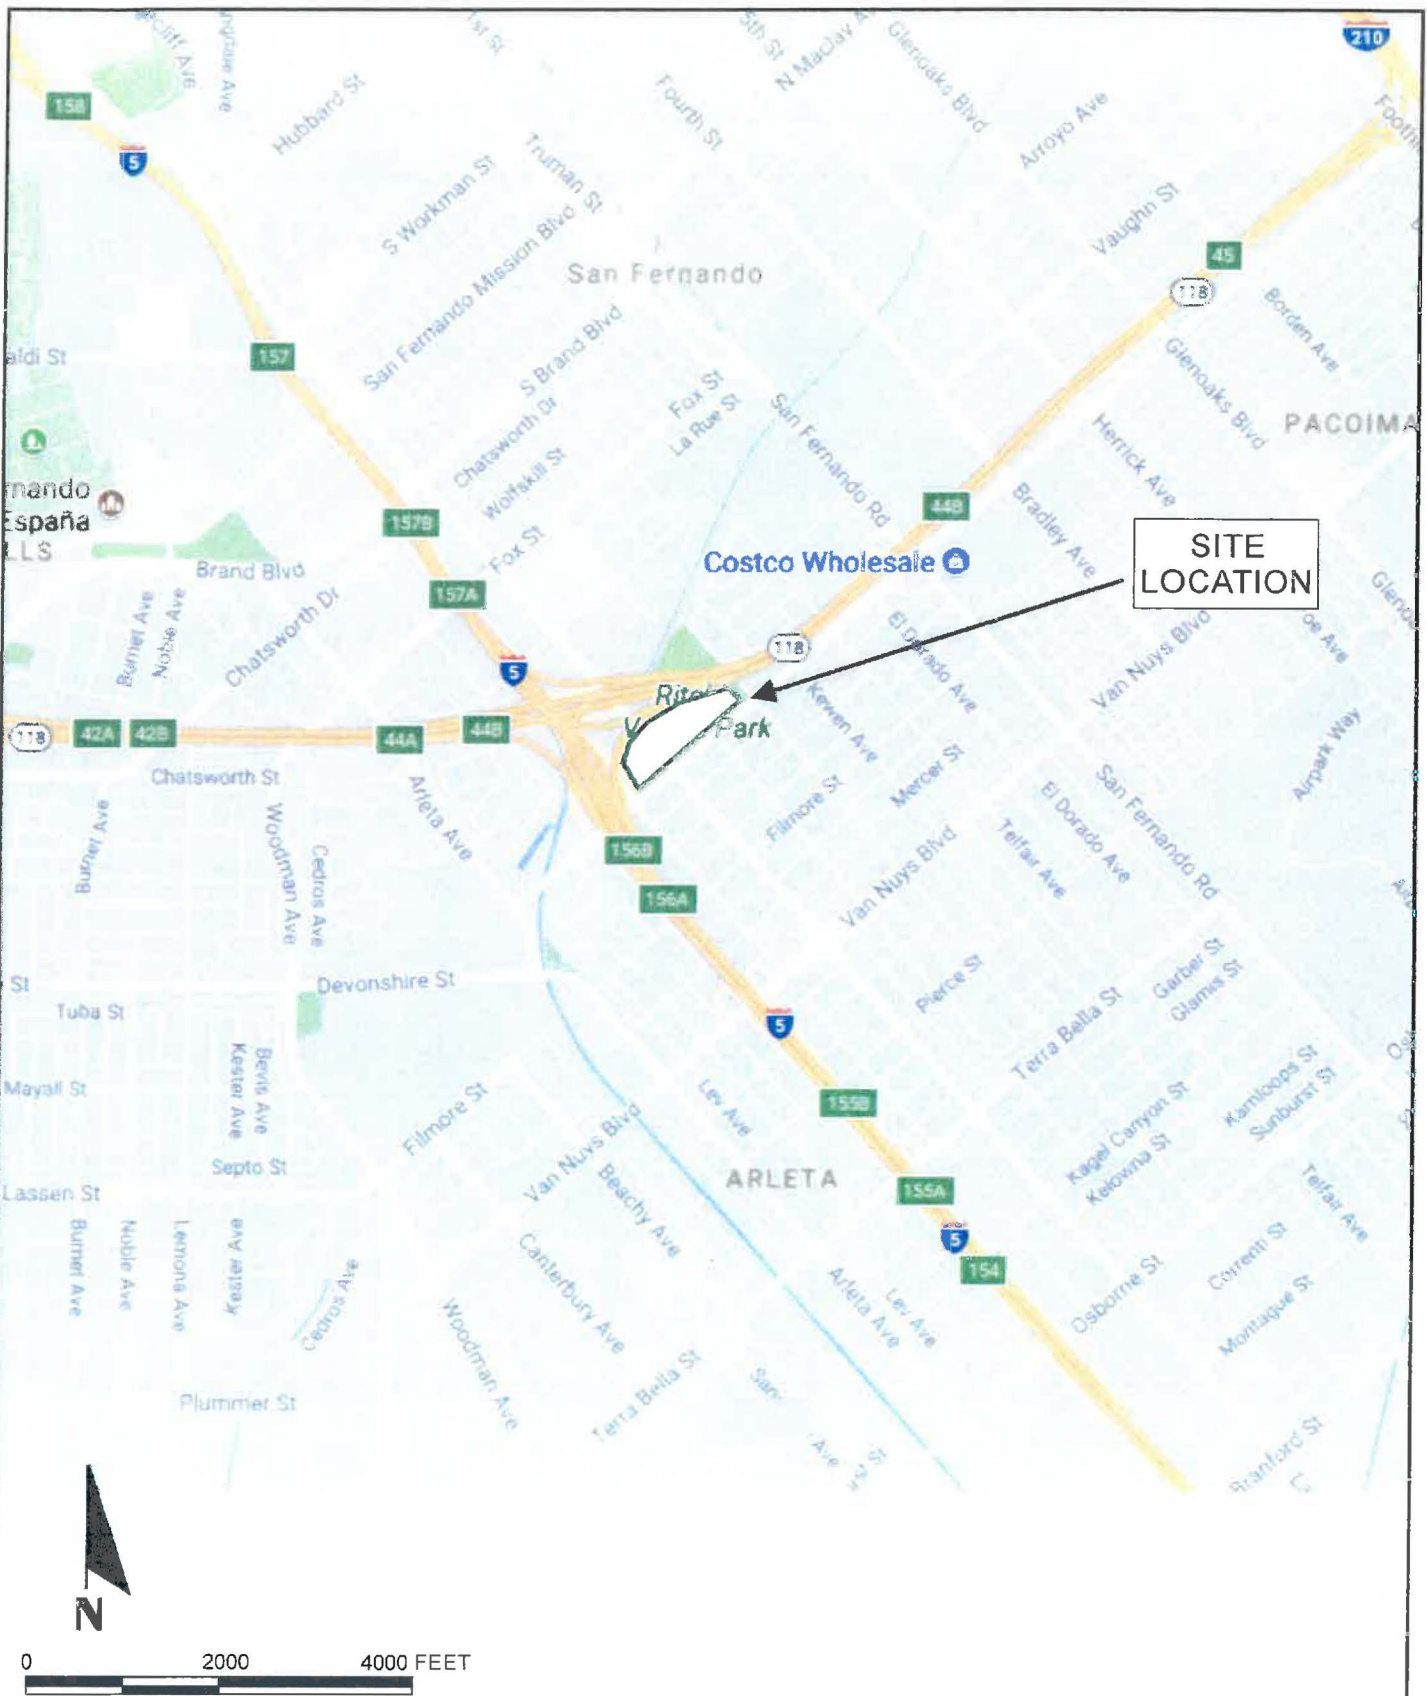
FIGURE 1

This report presents geotechnical data from a subsurface field investigation and laboratory testing performed by Geotechnical Professionals Inc. (GPI) for the subject project. The site location is presented in Figure 1.

BASE PLAN REPRODUCED FROM GOOGLE MAPS © 2017

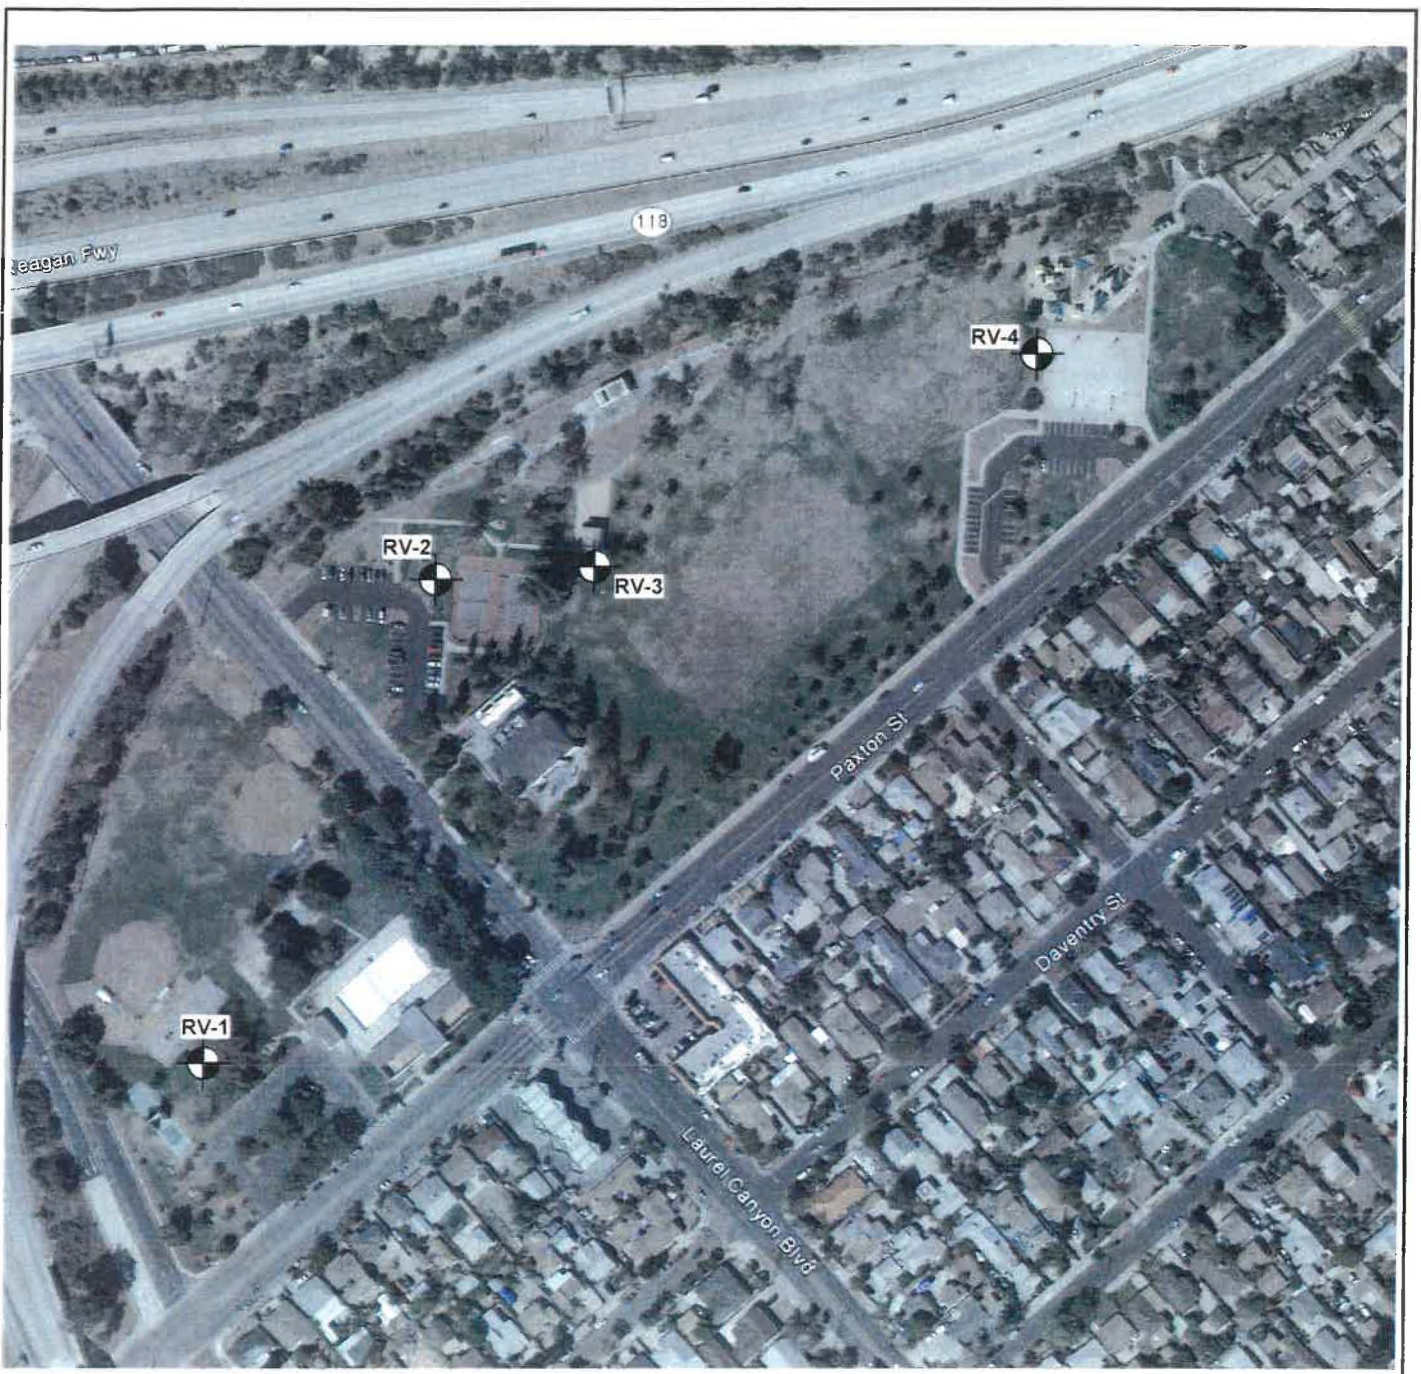
EXPLANATION

GPI drilled four hollow-stem auger (HSA) borings, each to a depth of approximately 21½ feet below ground surface (bgs). The boring locations are presented on the Site Plan, Figure 2, in GPI's data report (Appendix A).

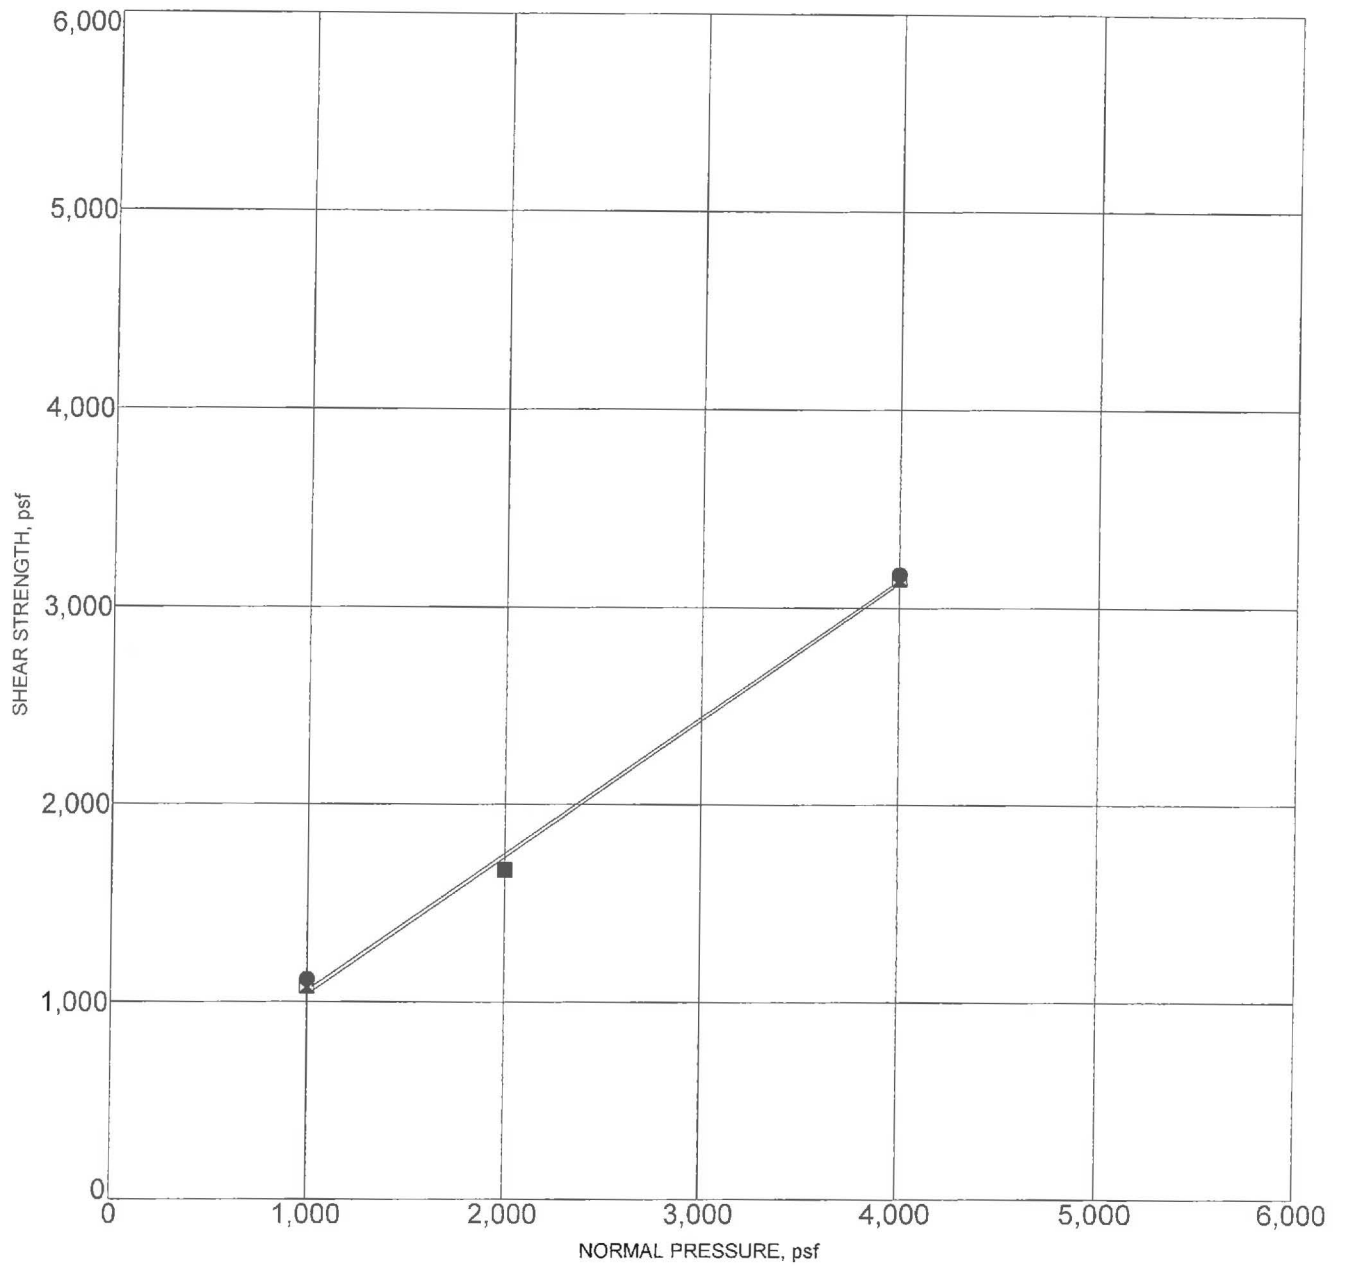
FIGURE B-1

● **PEAK STRENGTH**  
*Friction Angle= 35 degrees*  
*Cohesion= 366 psf*

⊠ **ULTIMATE STRENGTH**  
*Friction Angle= 35 degrees*  
*Cohesion= 342 psf*

**DIRECT SHEAR TEST RESULTS**

Three direct shear tests were performed on relatively undisturbed samples of the native sandy soil from RV-1 and RV-2. The sample depths ranged from approximately 5 to 10 feet. The test results indicate the ultimate friction angle and cohesion value of the native soil ranges from 33 to 36 degrees and 180 to 342 pounds per square foot (psf), respectively.

Direct shear tests were performed on undisturbed samples in accordance with ASTM D 3080. The samples were placed in the shear machine, and a normal load was applied. The samples were inundated for 2 hours, allowed to consolidate, and then were sheared to failure at a strain rate of 0.002 inches per minute. The tests were repeated on additional test specimens under increased normal loads. Shear stress and sample deformation were monitored throughout the test. The results of the direct shear tests are presented in Figures B-1 to B-3.

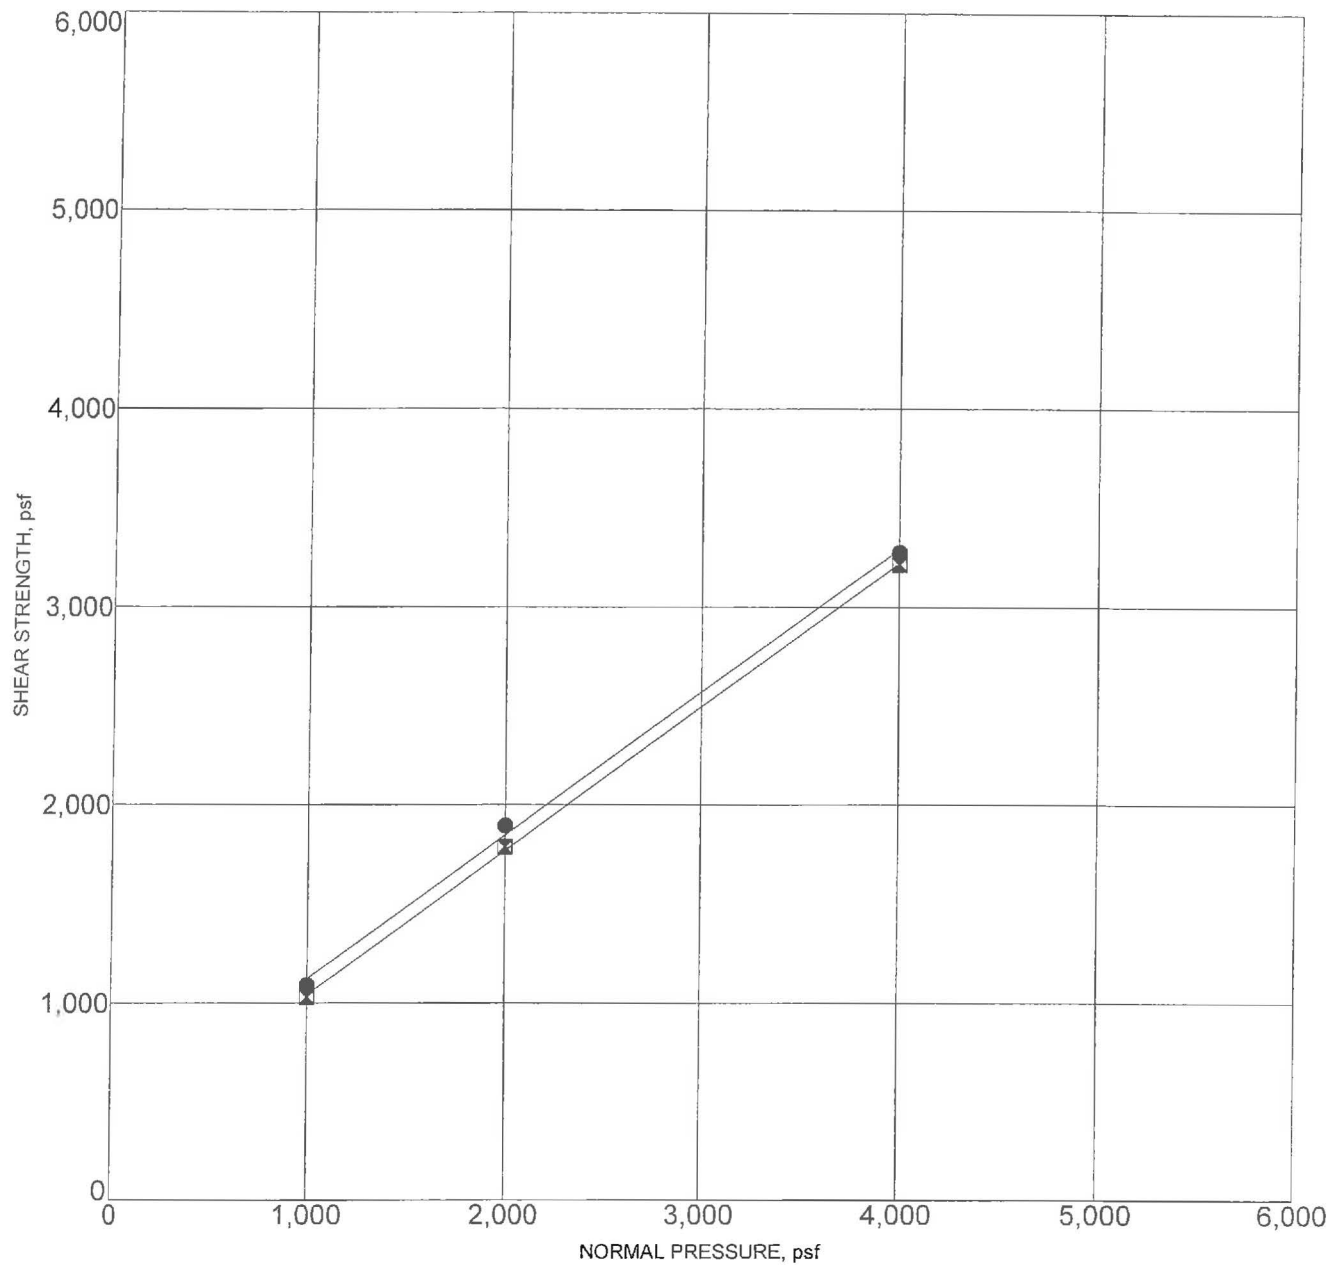
FIGURE B-2

● PEAK STRENGTH  
*Friction Angle= 36 degrees*  
*Cohesion= 402 psf*

⊠ ULTIMATE STRENGTH  
*Friction Angle= 36 degrees*  
*Cohesion= 318 psf*

**DIRECT SHEAR TEST RESULTS**

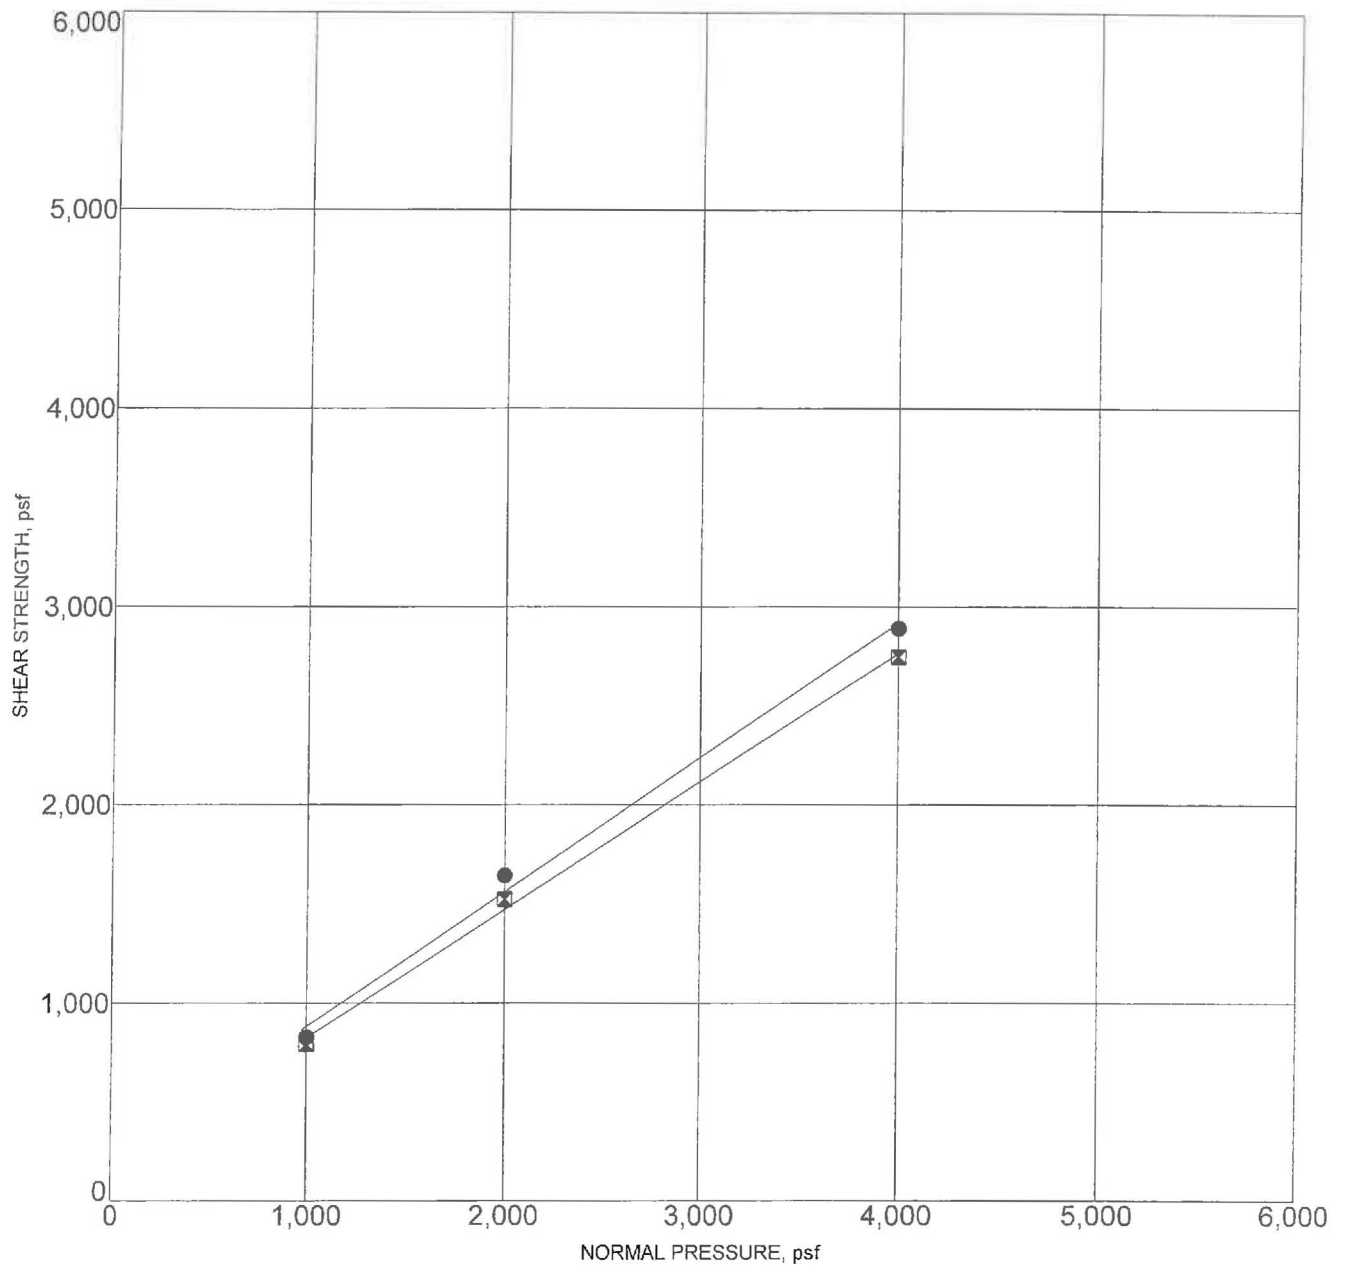
● **PEAK STRENGTH**  
*Friction Angle= 34 degrees*  
*Cohesion= 204 psf*

⊠ **ULTIMATE STRENGTH**  
*Friction Angle= 33 degrees*  
*Cohesion= 180 psf*

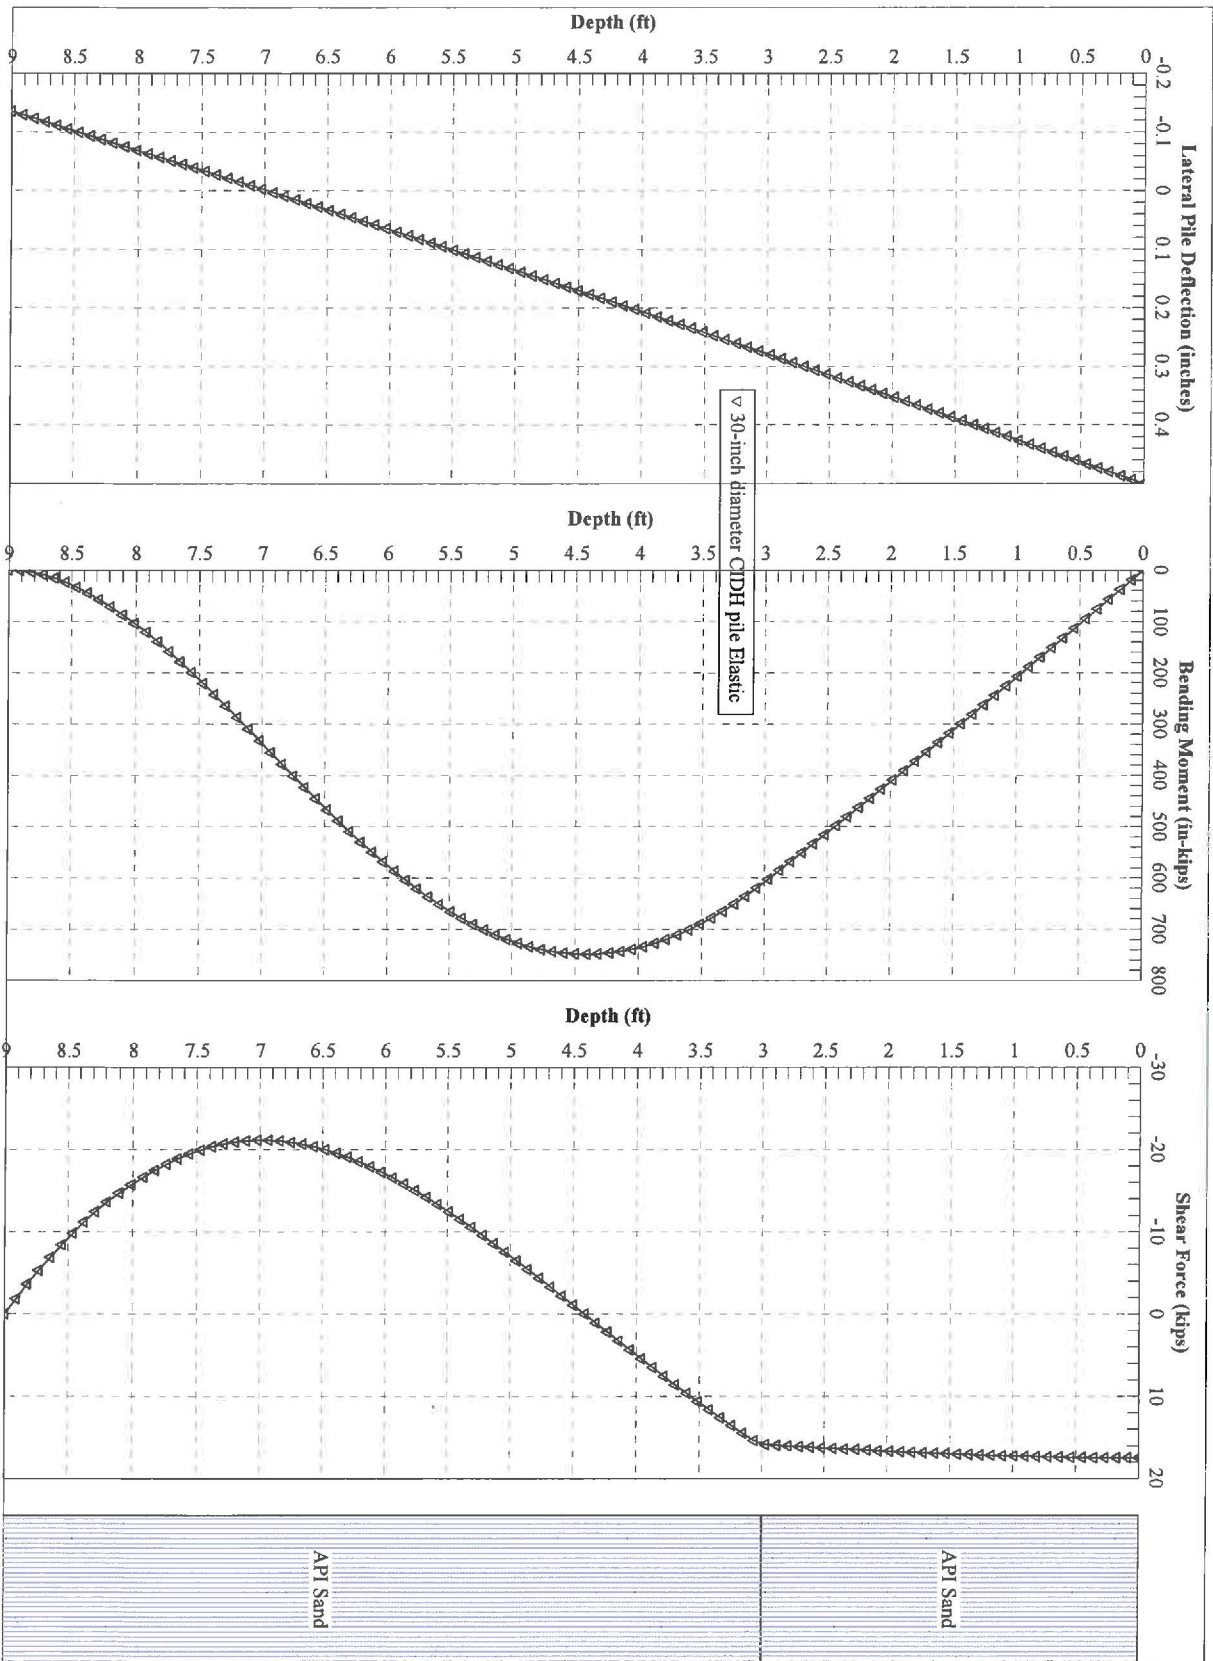
### **LPILE Results**

▽ 36-inch diameter CIDH pile Elastic

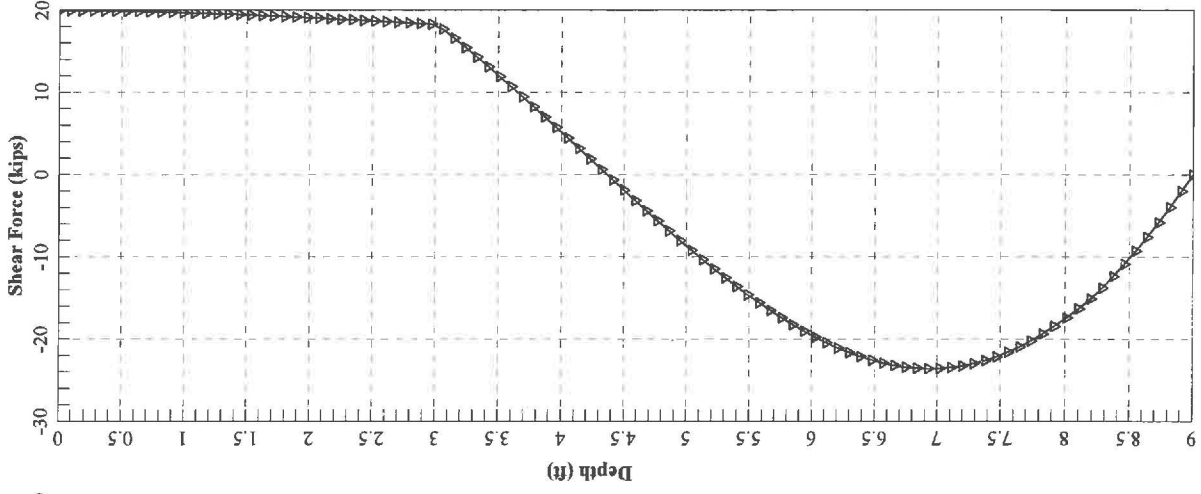
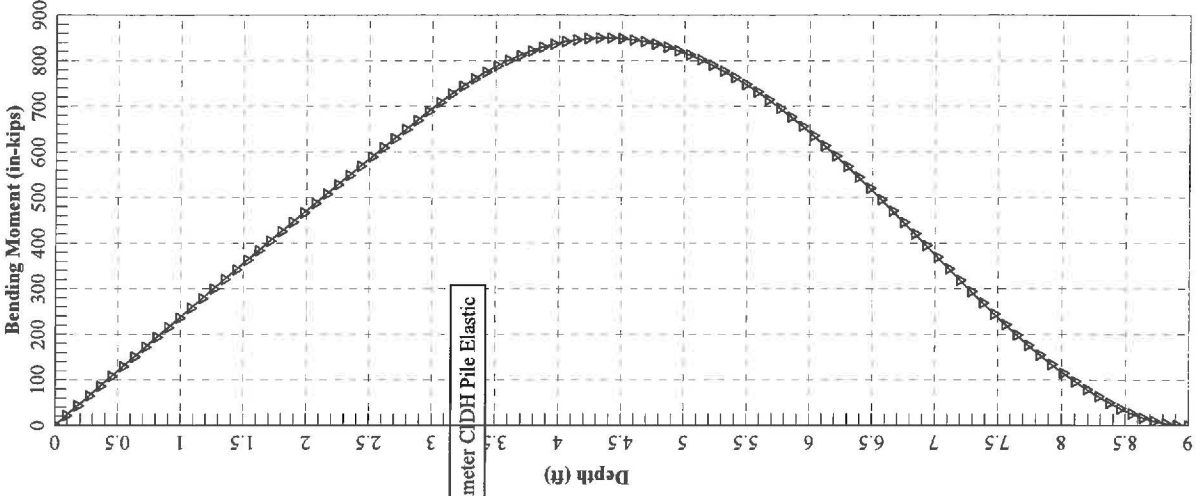
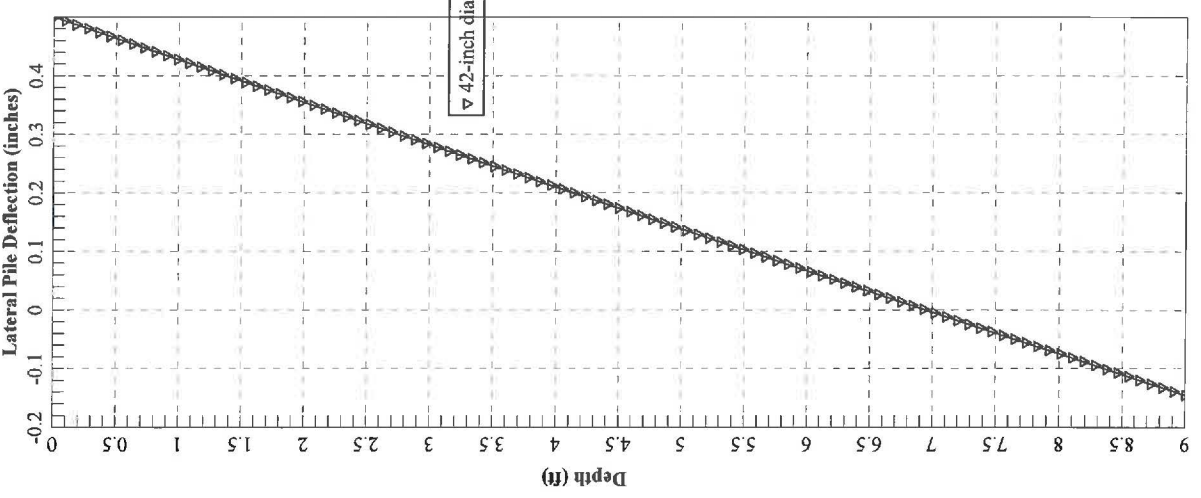
▽ 42-inch diameter CDH Pile Elastic

The lateral load behavior of the CIDH piles was evaluated using the LPILE (Ensoft, 2016) software program. The lateral load behavior was evaluated for a free head deflection of ½-inch. Also, we assumed a perfectly elastic pile and a cracked section. The modulus of elasticity for the cracked section was estimated to be 1802500 pounds per square inch.

The main inputs in the LPILE software for each soil layer are the unit weight and soils shear strength. The upper 3 feet of existing fill material was assumed to behave as “sand” with a total unit weight of 98 pounds per cubic foot (pcf), an effective friction angle of 20 degrees, and no cohesion. A request for modification of building ordinances for deriving lateral support from the existing uncertified fill will be submitted concurrently with this report. The native soil was assumed to behave as “sand” with a total unit weight of 120 pounds per cubic feet (pcf), and an effective friction angle of 35 degrees, and no cohesion. The results of the LPILE analyses are presented in Appendix B.
