STANWYCK RESIDENCE/OAKRIDGE ESTATE HISTORIC STRUCTURE REPORT

Prepared for
City of Los Angeles
Department of Recreation and Parks

Prepared by
Chattel Architecture, Planning & Preservation, Inc.
Los Angeles | San Francisco

April 2012

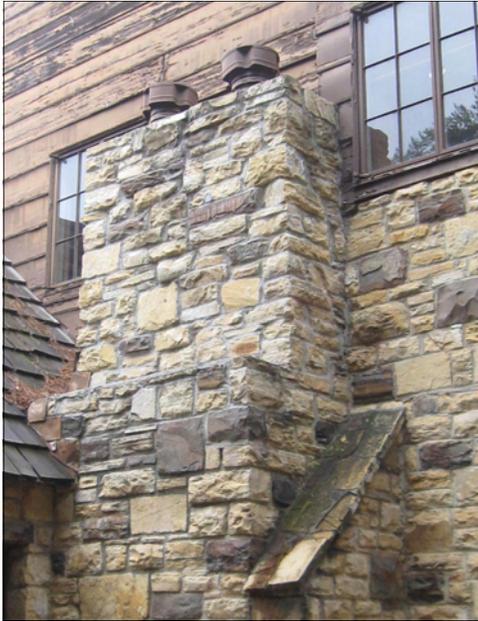
Chimney with upper portion removed (Chattel, 2011)

The most notable changes made to the exterior involved removal of the upper portions of three chimneys, likely due to seismic corrections (date unknown, though likely following the 1994 Northridge Earthquake, Figure 63). Minor changes made to interior spaces include application of new wallpaper and introduction of new paint colors and stains on interior wood paneling. For example, a photograph of Stanwyck taken in the dining room (Figure 8) shows dark stained wood wainscot, which was later painted a lighter color. Historic photos also show changes made to the great room, which was originally characterized by a more rustic ambiance. The great room included textured wood paneling, comparable in style to paneling in the den, in addition to a fireplace clad in limestone veneer, matching the residence exterior, with no mural (Figure 7). Great room alterations were made during the residence's period of significance and have taken on importance in their own right. While the property has sat vacant, interior fixtures and furnishings have been removed. Windows have been temporarily covered with plywood to prevent further vandalism and theft.

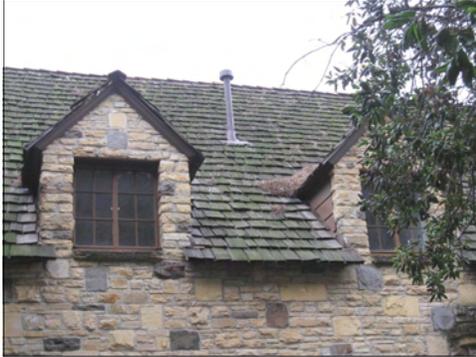
Dormers at north elevation, view south
(Chattel, 2011)

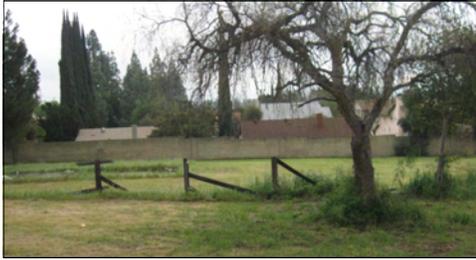
Wood fence remnant in field (Chattel, 2011)

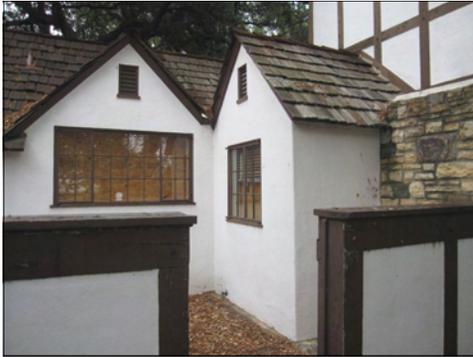
Rear patio can be modified for accessible entry, and dining nook (right) serves as an appropriate location for construction of an elevator shaft, view north (Chattel, 2011)

Options to improve first floor accessibility (Figure 79) should be considered to avoid altering the single flagstone step at the main entry (Space 1), which is a significant feature. Located at a less visible, secondary elevation, the rear patio (Space 12) and adjacent kitchen wing vestibule entrance could be modified to serve as an appropriate location for new accessible entry (Figure 80). In conformance with the CHBC, this entrance is within 200 feet of the main entry, which serves as a primary entrance. Widths

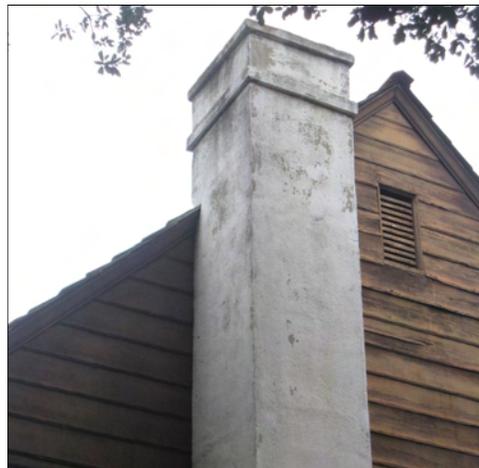
Dumbwaiter shaft exterior, view east (Chattel, 2011)

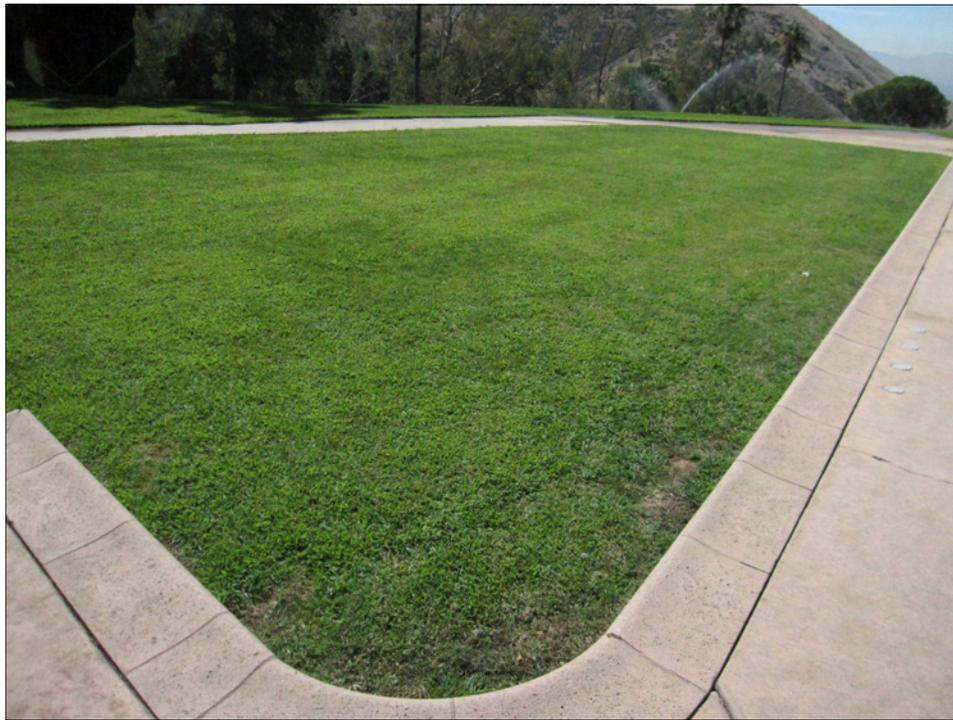
86: Example of swimming pool filled in reversible manner and covered with lawn at Arrowhead Springs Resort in San Bernardino, CA (Chattel, 2011)

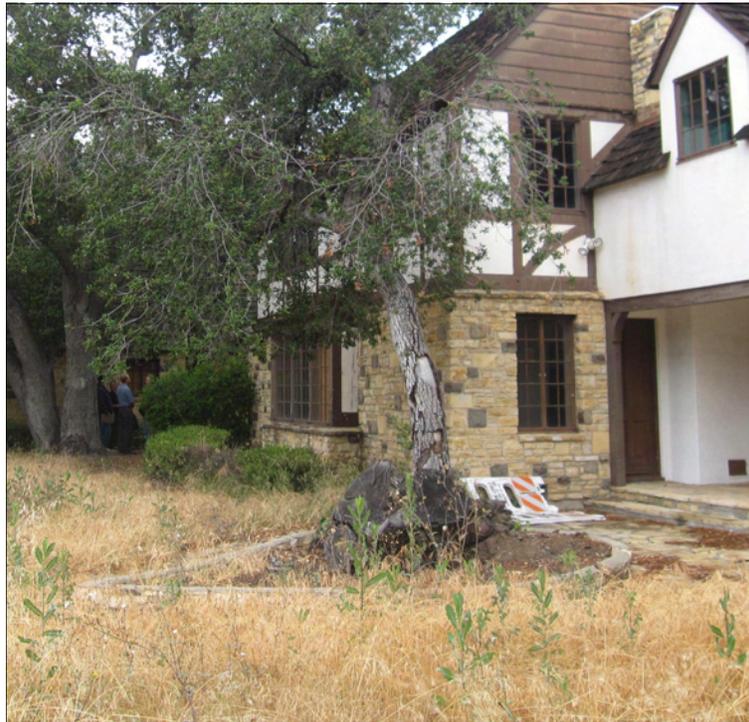
89: Only a stump and small branch remain of oak tree #165; weeds and volunteer vegetation have grown in areas formerly occupied by lawns (Chattel, 2011)
